Liveable Neighbourhoods Zone 04 - Winifred's Lane

Stage 3 Road Safety Audit

Bath and North East Somerset Council

April 2025

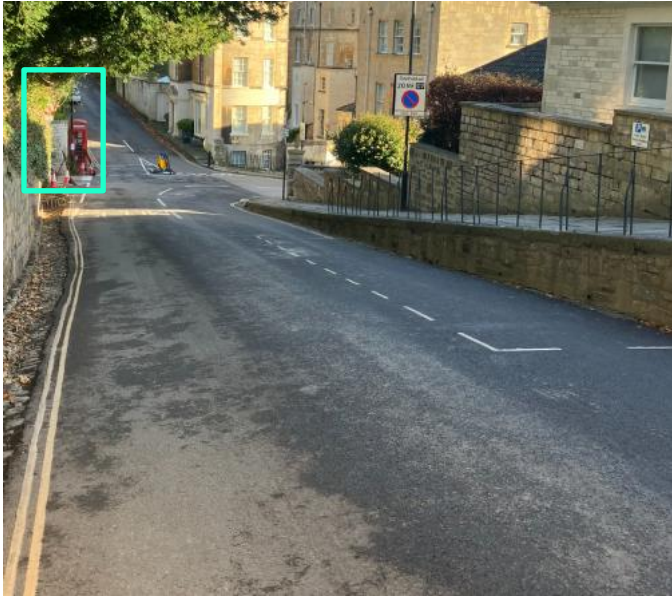
Problem: E1.2	
Drawing Number(s):	60668625-ACM-04-DD-LL_ETRO-SHT-0101B.
Location:	Sion Hill.
Summary:	<i>Proposed signage may be obstructed by existing vegetation, resulting in motorists undertaking prohibited manoeuvres and causing head on or graze type collisions with other road users.</i>
Description:	
<i>The proposals mount a prohibited turning sign onto an existing post on Sion Hill; however, during the site visit the Audit Team observed the existing sign to be obstructed by vegetation. If the overhanging vegetation is not cut back and maintained, once the proposed signage is in place, motorists approaching Winifred's Lane from Sion Hill may be unaware of the prohibited vehicular movements along Winifred's Lane due to the obstructed visibility to the sign. This may result in motorists turning left on to Winifred's Lane and causing a head on or graze type collision with other road users.</i>

Recommendation:	
<i>It is recommended that a maintenance plan is put in place and the vegetation is cut back and maintained regularly.</i>	
Designers Response:	
<i>Agree with the recommendation</i>	
<i>Regular maintenance will be undertaken to remove overgrown vegetation for the duration of the experimental order.</i>	
Overseeing Organisation Response:	
<i>The Overseeing Organisation agrees with the Designer Organisation response.</i>	
Road Safety Audit Stage 3 Comments:	
During the site visit, the Audit Team observed the new signage to be obstructed by vegetation. Therefore, this issue remains outstanding.

Road Safety Audit Stage 3 Designers Response:	
<i>Agree with the recommendation.</i>

Road Safety Audit Stage 3 Overseeing Organisation Response:
Agree with the recommendation. A maintenance plan is in place.

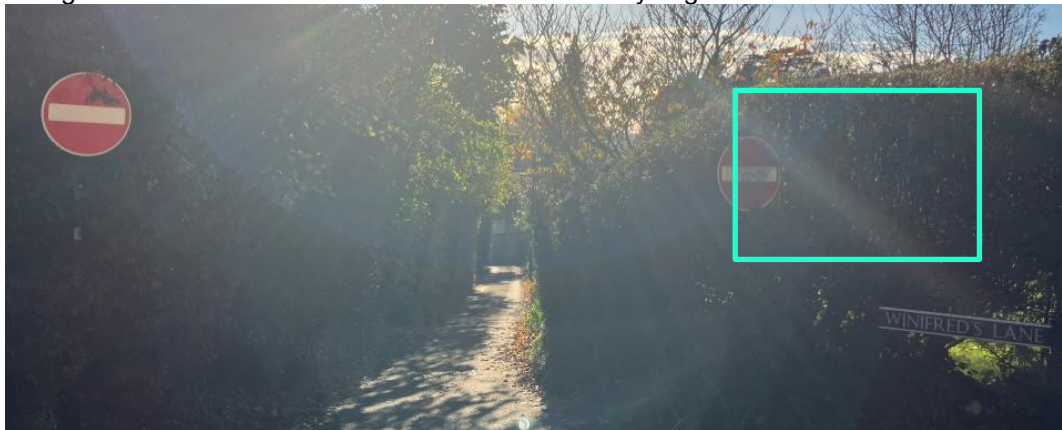
Problem: E1.3	
Drawing Number(s):	60668625-ACM-04-DD-LL_ETRO-SHT-0101A.
Location:	Northern end of Winifred's Lane (junction with Sion Road and Hermitage Road).
Summary:	Proposed signage may be obstructed by existing vegetation, resulting in drivers undertaking prohibited manoeuvres and causing head on or graze type collisions with other road users.
Description:	
<p>The proposals outline the use of No Entry signage with yellow backing boards, mounted onto the existing posts at the northern end of Winifred's Lane (junction with Sion Road and Hermitage Road); however, during the site visit the Audit Team observed substantially overgrown vegetation is masking the existing No Entry signage.</p> <p>The Audit Team is concerned that if the existing overgrown vegetation is not maintained, once the proposed signage is in place, drivers approaching Winifred's Lane from Sion Road may be unaware of the prohibited vehicle movements along Winifred's Lane due to the obstructed visibility to the sign. This may result in drivers turning on to Winifred's Lane, increasing the likelihood of a head on or graze type collision with other road users.</p>

Recommendation:	
It is recommended that a maintenance plan is put in place and the vegetation is cut back and maintained regularly.	
Designers Response:	
<p>Agree with the recommendation</p> <p>Regular maintenance will be undertaken to remove overgrown vegetation for the duration of the experimental order.</p>	
Overseeing Organisation Response:	
The Overseeing Organisation agrees with the Designer Organisation response.	
Road Safety Audit Stage 3 Comments:	
<p>During the site visit, the Audit Team acknowledged that the vegetation had been cut back around the "no entry" signs; however, this has left the sign itself covered in debris and may reduce visibility for motorists to the sign. It is therefore recommended that the "no entry" sign is cleaned.</p>

Road Safety Audit Stage 3 Designers Response:	
<p>Agree with the recommendation.</p> <p>The vegetation will require regular maintenance and the sign face to be cleaned of debris.</p>

Road Safety Audit Stage 3 Overseeing Organisation Response:	
Agree with the recommendation. Regular maintenance will take place and the sign will be cleaned as part of this maintenance.

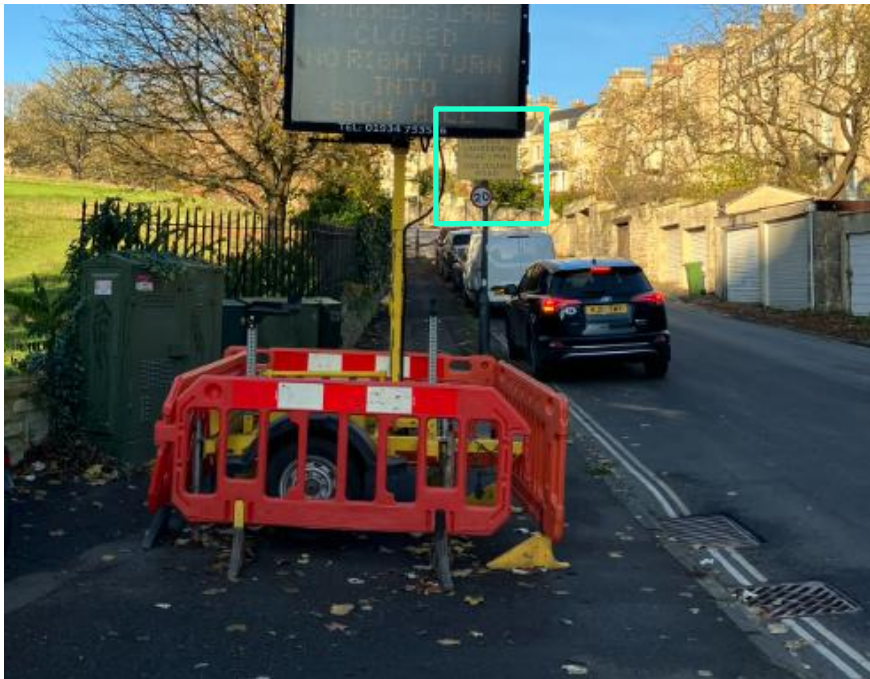
Problem: E1.4	
Drawing Number(s):	60668625-ACM-04-DD-LL_ETRO-SHT-0101C.
Location:	Weston Road.
Summary:	Lack of advanced warning sign for prohibited vehicle movements may result in vehicles undertaking sudden manoeuvres, resulting in rear end shunt or graze type collisions.
Description:	
The proposals prohibit vehicle access to Lansdown Road (and the M4) from Cavendish Road to reduce the amount of potential "rat running" along Sion Hill (east); however, vehicles approaching Cavendish Road from Weston Road are not provided with advanced warning of this restriction. This may result in vehicles undertaking sudden manoeuvres at the junction of Weston Road / Cavendish Road as they approach the proposed warning sign, causing rear end shunts or graze type collisions with other road users.	
Recommendation:	
It is recommended that an advanced warning sign is placed on Weston Road before the junction with Cavendish Road indicating to drivers that all routes are to be accessed along Julian Road.

Designers Response:	
Partially agree with the recommendation	
The junction is a conservation area therefore sign clutter is to be kept at a minimum. Therefore, the text on the proposed sign will be amended to include the additional words 'USE JULIAN ROAD' at the end of the sentence.	
Designer Organisation Response:	
Partially agree with the recommendation	
The junction is a conservation area therefore sign clutter is to be kept at a minimum. Therefore, the text on the proposed sign will be amended to include the additional words 'USE JULIAN ROAD' at the end of the sentence.	
Road Safety Audit Stage 3 Comments:	
Although the sign located on Cavendish Road includes the wording "use Julian Road", it does not provide advanced warning. This may result in drivers undertaking sudden manoeuvres or unsuitable turns in the road upon realising that access cannot be gained, causing graze type or rear end shunt collisions. Therefore, this issue remains outstanding.

The 'For Construction' drawing issued to the contractor, 60668625-ACM-04-LL_ETRO-SHT-0100-001-0101C-C05, specified the sign to be positioned on a new post at the start of Cavendish Road. In the specified location, drivers could read the sign before turning into Cavendish Road. The information sign has not been located correctly and the sign should be relocated as per the drawing.

Agree with Designers Response, emphasising the importance of this advanced signage for any camera enforcement in this area.

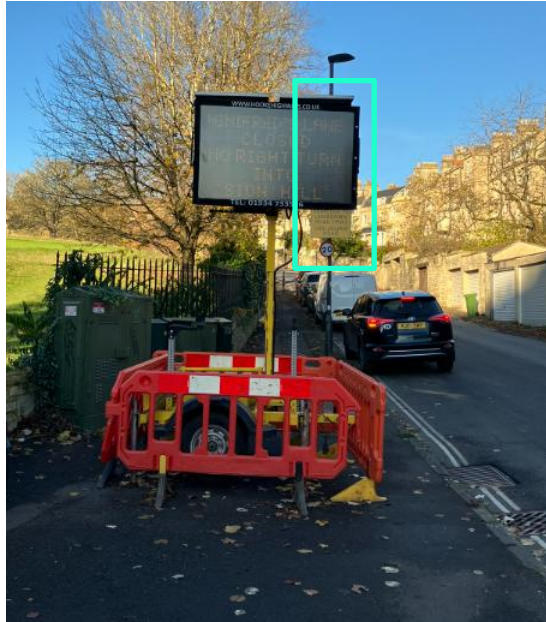
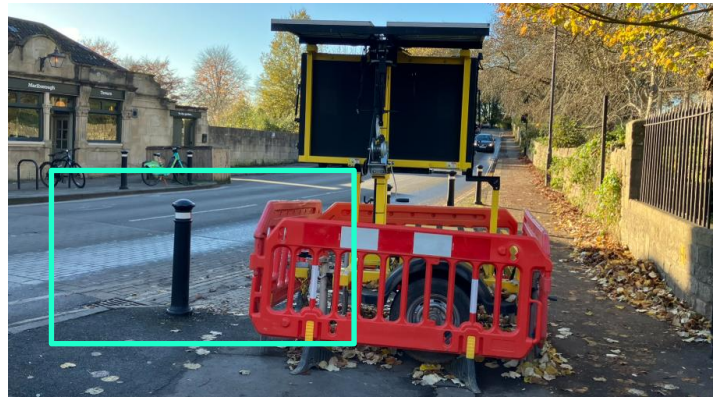
Problem: E1.1	
Drawing Number(s):	60668625-ACM-04-DD-LL_ETRO-SHT-0101C.
Location:	Cavendish Road / Julian Road junction.
Summary:	Location of Variable Message Signs (VMS) cause an obstruction which may result in personal injury or rear end shunt collisions.

Temporary Variable Message Signs have been installed at the junction of Cavendish Road / Julian Road / Weston Road. However, the location of these signs mask permanent signage which is part of the scheme and obstruct an existing pedestrian crossing. This may result in personal injury collisions or rear end shunt collisions, if drivers undertake sudden manoeuvres.

It is recommended that the temporary VMS are relocated.

The VMS sign was temporarily placed in this location to provide drivers with additional information and has now been removed.

The VMS sign was temporary and has now been removed.

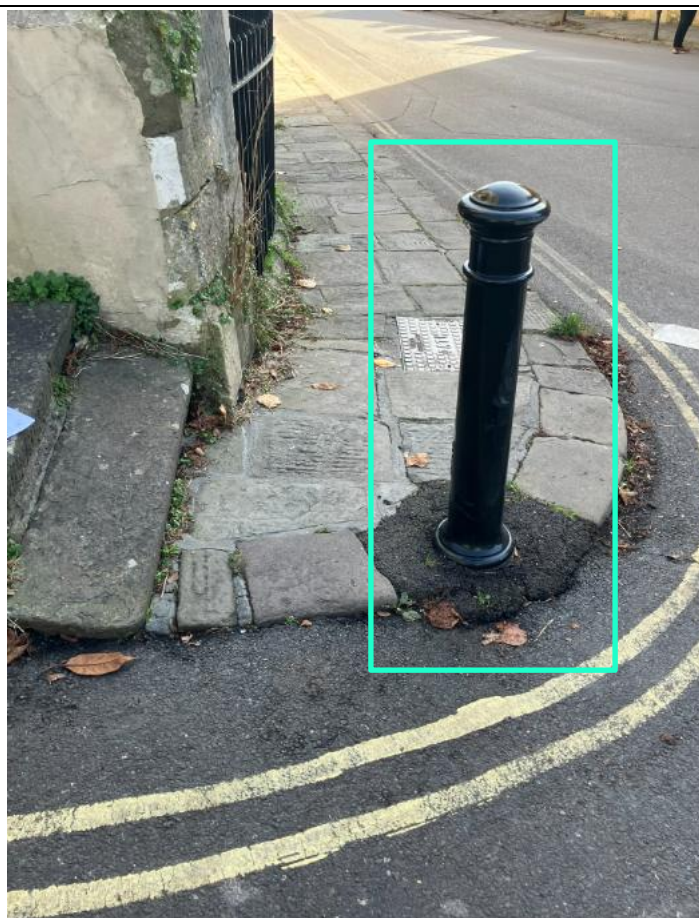
Problem: E4.1	
Drawing Number(s):	60668625-ACM-04-DD-LL_ETRO-SHT-0101B.
Location:	Sion Hill egress.
Summary:	Lack of reflective strip on bollard may result in a graze type collision, particularly during the hours of darkness.

A new bollard has been installed on the eastern footway at the junction of Sion Hill (east) and Cavendish Road. However, there is no reflective strip located on the bollard. This may result in a vehicle inadvertently striking the kerb or bollard due to it not being visible to drivers, particularly during the hours of darkness, causing a strike or graze type collision.

It is recommended that a reflective strip is placed on the bollard.

The bollard identified was not installed as part of this scheme. This comment will be passed to the Highway Authority and a reflector strip to be added to the bollard.

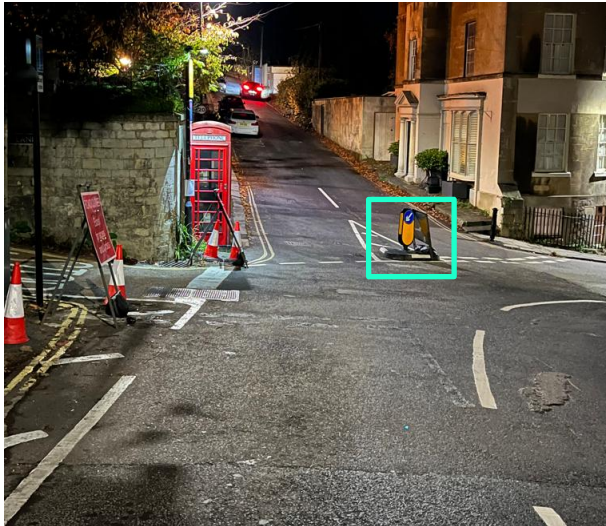
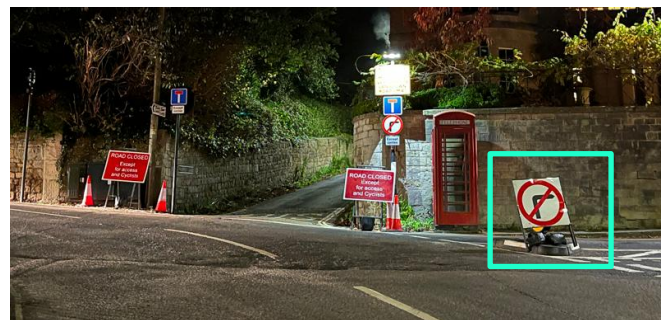
Problem: E4.2	
Drawing Number(s):	60668625-ACM-04-DD-LL_ETRO-SHT-0101B.
Location:	Cavendish Road / Sion Hill junction.
Summary:	Location of temporary signage obstructs reflectivity of bollard located on a central island, which may result in a vehicle striking the bollard or kerb of the central island, particularly during the hours of darkness.

Temporary signage has been installed around Winifred’s Lane and along Sion Hill and Cavendish Road. However, one temporary sign which informs drivers of the banned right turn movement onto Sion Hill (east) is located on the newly constructed central island at the junction access/egress to Sion Hill (east). The sign overhangs the central island, which may result in a vehicle striking the sign as a driver negotiates the bend, particularly larger vehicles. This is further exacerbated as the sign blocks visibility to the white lining painted on the kerb line of the central reserve which is reflective during the hours of darkness.

In addition, the sign obstructs the reflective bollard located on the central island and therefore reduces visibility to the central island for approaching drivers, particularly during the hours of darkness. This is further exacerbated by the orientation of the bollard which does not face drivers in vehicles approaching from Sion Hill (west) travelling eastbound and Sion Hill (east) travelling westbound. This may result in vehicles striking the central reserve and result in a loss of control collision.

It is recommended that the temporary sign is relocated away from bollard onto the northern footway and the bollard is orientated correctly to oncoming vehicles.

The temporary sign, placed by the contractor, should be relocated so as to not block the bollard. Alternatively, if the sign is no longer needed, it should be removed.

The bollard should be orientated to face Sion Hill (east), as specified on the ‘For Construction’ drawing.

Agree that the bollard should be reorientated to face Sion Hill (east) as specified on the ‘For Construction’ drawing.

The installation of larger no right turn sign faces and the introduction of education and enforcement should negate the need for temporary signage in the future.
