**Timsbury and Farmborough area:
Flooding Incident May 2016**
Flood and Water Management Act, Section 19 Flood
Investigation Report

June 2016

Flood and Water Management Act, Section 19 Flood Investigation Report
Prepared by Bath and North East Somerset Council

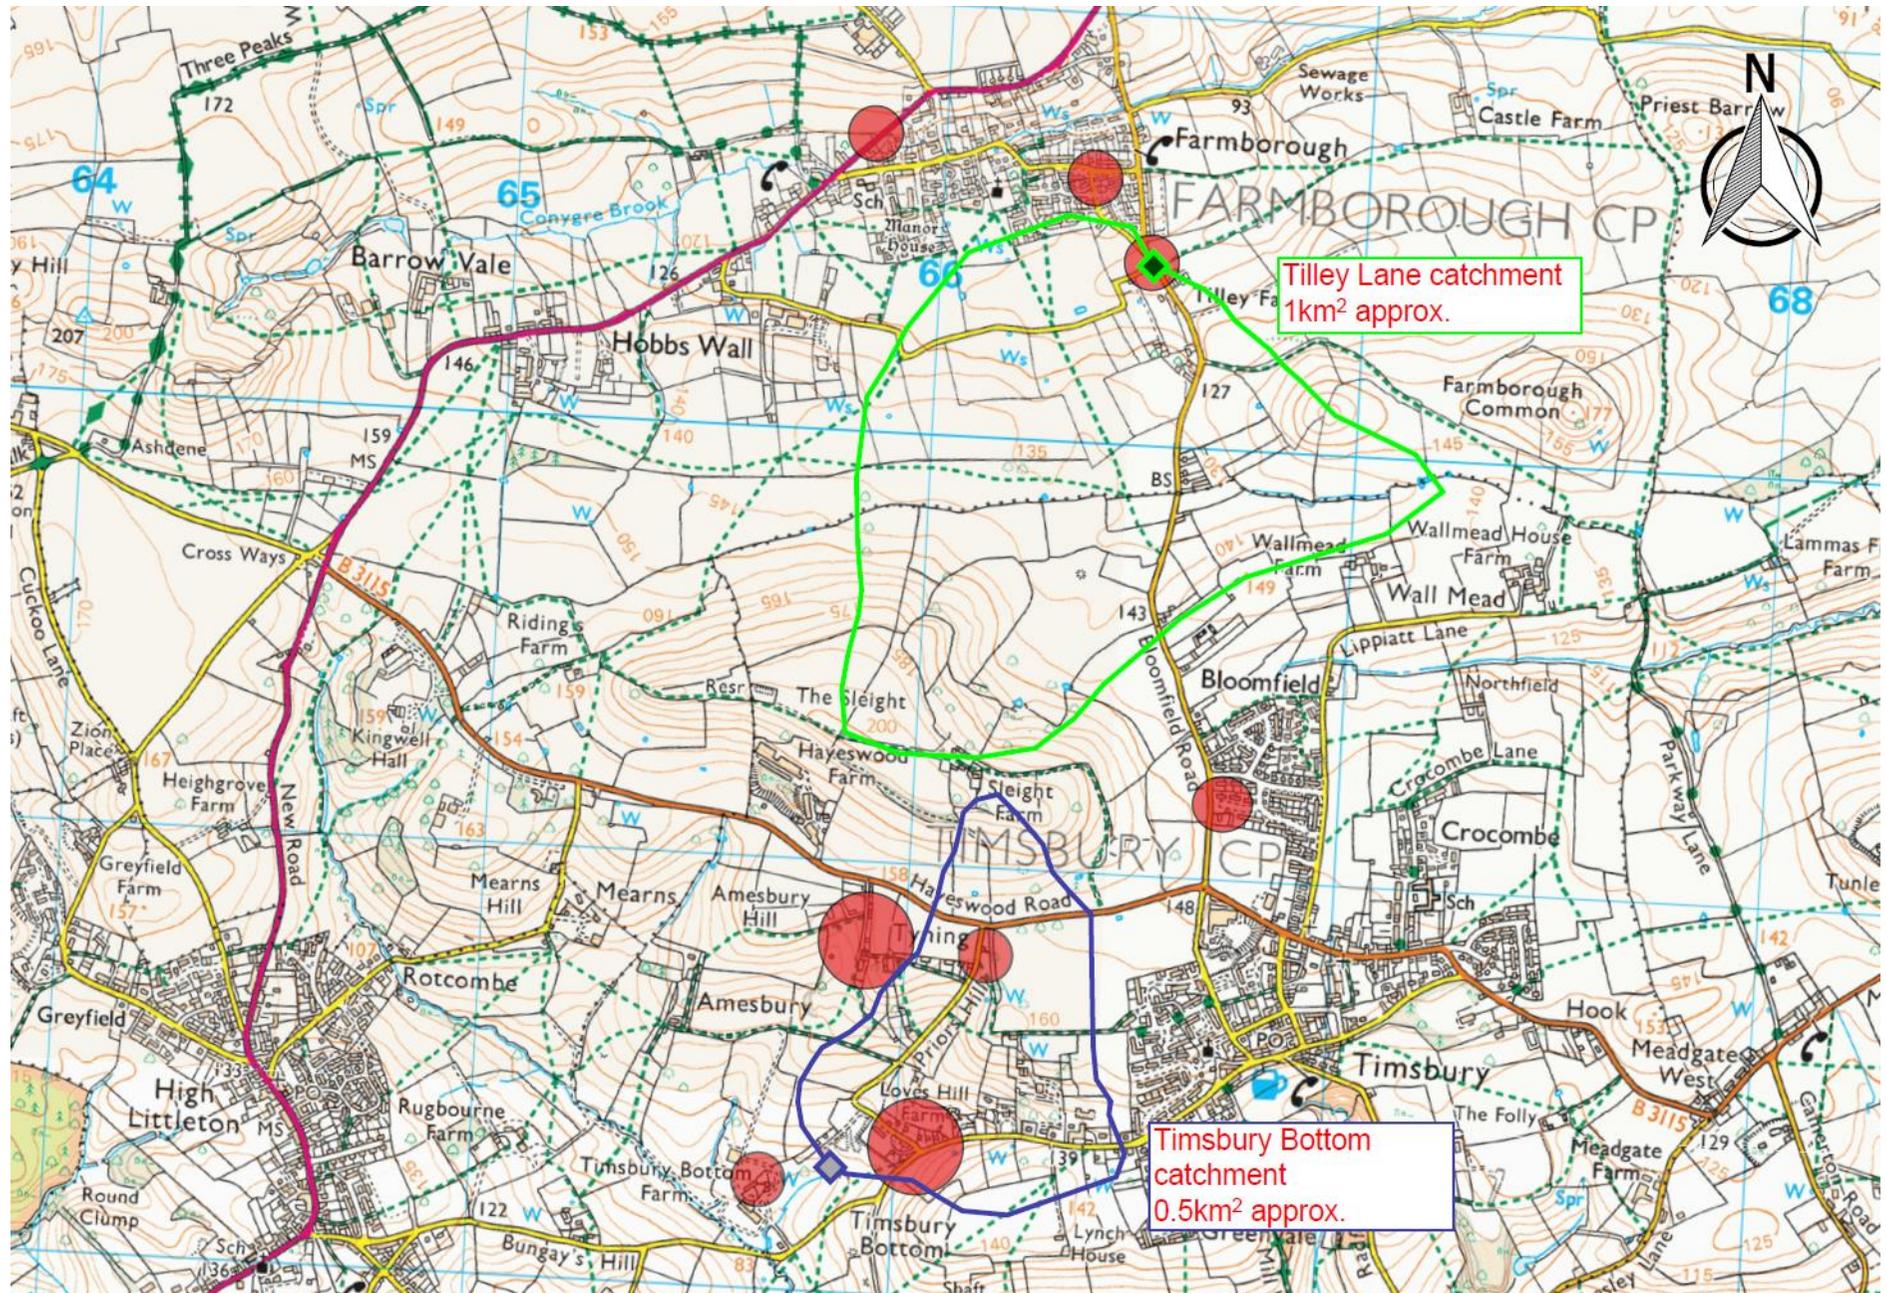
Figure 2.1: Locations of flood affected areas (size of circle indicates severity)

Location	Internal property flooding	Significant highway flooding	Flooding to outbuildings (garages/ sheds) and grounds
Tilley Lane/ Timsbury Road, Farmborough	-	1	1
Bellifants/ Timsbury Road, Farmborough	-	-	1
Bath Road, Farmborough	-	-	1
Tynning area, Timsbury	1	-	1
Timsbury Bottom area, Timsbury	4	-	2
Bloomfield Road area, Timsbury	-	-	1
Top of Priors Hill	-	-	1
Totals	5	1	8

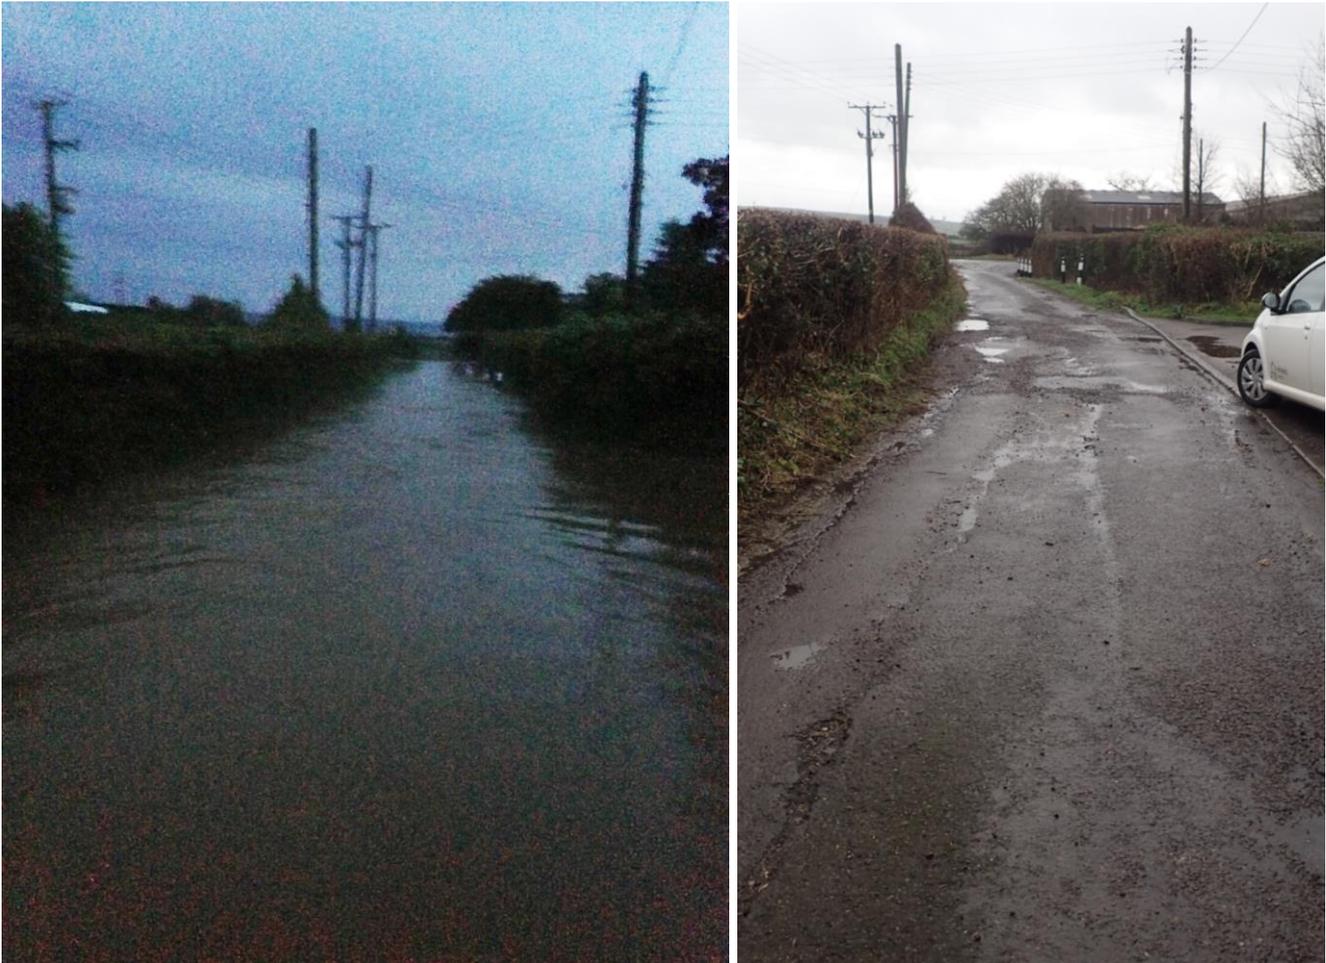
The junction of the eastern end of Tilley Lane and Timsbury Road are located at a natural low spot for a predominantly rural catchment of just over 1km². Environment Agency surface water flood maps show that this area is at high risk of surface water flows (greater than 1 in 30 chance of occurrence in any year). At this junction Timsbury Road is raised above the level of the adjoining Tilley Lane resulting in a restriction to overland flows.

On the evening of Friday 27 May surface water runoff flowed into this area reaching depths of around 500mm on some parts of Tilley Lane and significant depths on Timsbury Road. One property in the area used sandbags to try to stop ingress of water and parts of a workshop/garage for this property were flooded to a low level. Motorised traffic travelling through flood waters on Timsbury Road posed a risk to life. Debris from the flood water (including parts of damaged cars) ended up being deposited on downstream private land.

This area experienced similar flooding in February 2016 and has a general history of flooding.

(Left – Tilley Lane on the evening of 27 May. Right: Tilley Lane normal conditions)
