Client BATH AND NORTH EAST SOMERSET COUNCIL

> In respect of Keynsham High Street KEYNSHAM

Stage 4 Road Safety Audit

December 2023

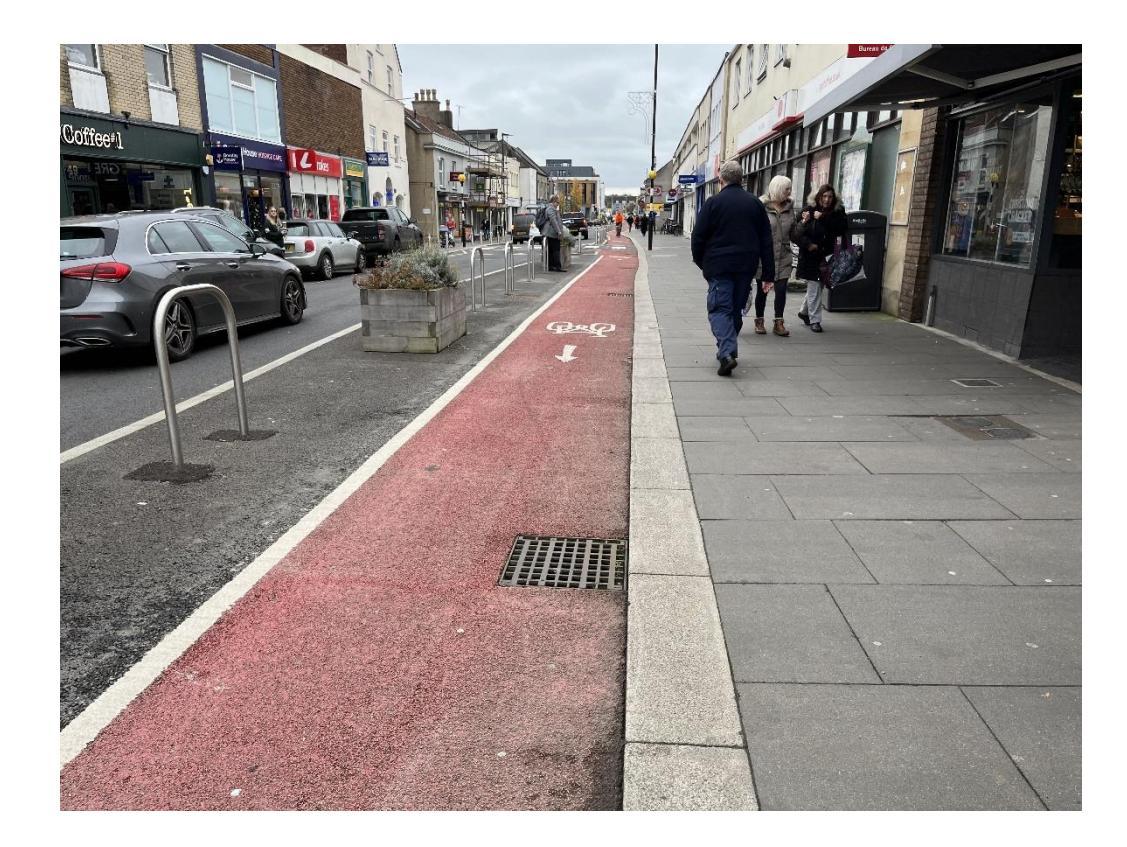
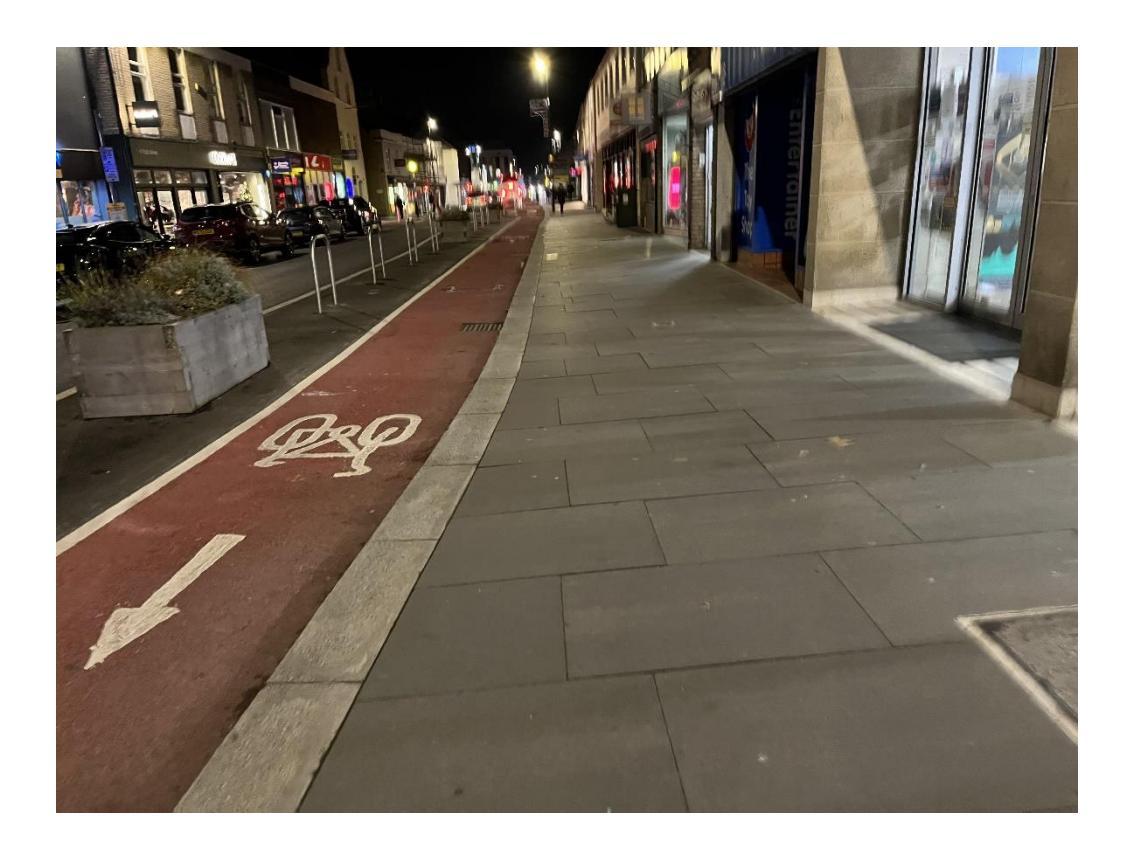
Summary: Risk of pedestrian trips / falls

The 50mm height kerb between the cycleway and footway is not clearly visible (and further reduced at night) and it is clear from the number of incidents reported since opening that this has led to a number of pedestrian trips / falls. From the incident descriptions provided, it is clear that a large proportion of these are related to pedestrians walking along, rather than crossing, High Street, whether that be because they are stepping around other pedestrians or they simply have not recognised the presence of the kerb. It is noted that the scheme has been designed and delivered in accordance with the appropriate guidance set out in LTN1/20 and we are not aware of similar issues at other schemes where this type of design has been implemented. However, there is clearly some combination of factors in this location (and not any that are clearly identifiable to the Audit Team) which mean that there is a risk of pedestrian trips/falls.

RECOMMENDATION

It is recommended that stick-on corduroy tactile paving is applied along the kerb edge to highlight the level change and to deter pedestrians from walking along the kerb edge.

The design team have considered the Auditors recommendation of installing stick on tactile hazard warning paving adjacent to the kerb line to warn pedestrians of the change in levels. The design

team has no objections to this proposal from a Road safety perspective; however it should be noted that stick on tactiles may not meet with the schemes heritage objectives and are likely to lead to long term maintenance issues. A more permanent solution would be to install replacement tactile hazard warning slabs which would require approximately 100m of saw-cutting and slab laying. There is a question however, as to whether the users of Keynsham highstreet would understand what the tactile paving means and whether they would deter people from stepping off the kerb line in this manner. Typically tactile paving of this sort is to aid partially sighted or visually impaired people who have been trained to understand the purpose of different tactile surfaces. This isn't necessarily the primary demographic involved in the reported incidents. An alternative would be to install bollards along the kerb line which may discourage people from walking along it the kerb edge. This should be balanced against the level of "clutter" created in the built environment, noting that minimising clutter was an objective of the scheme.

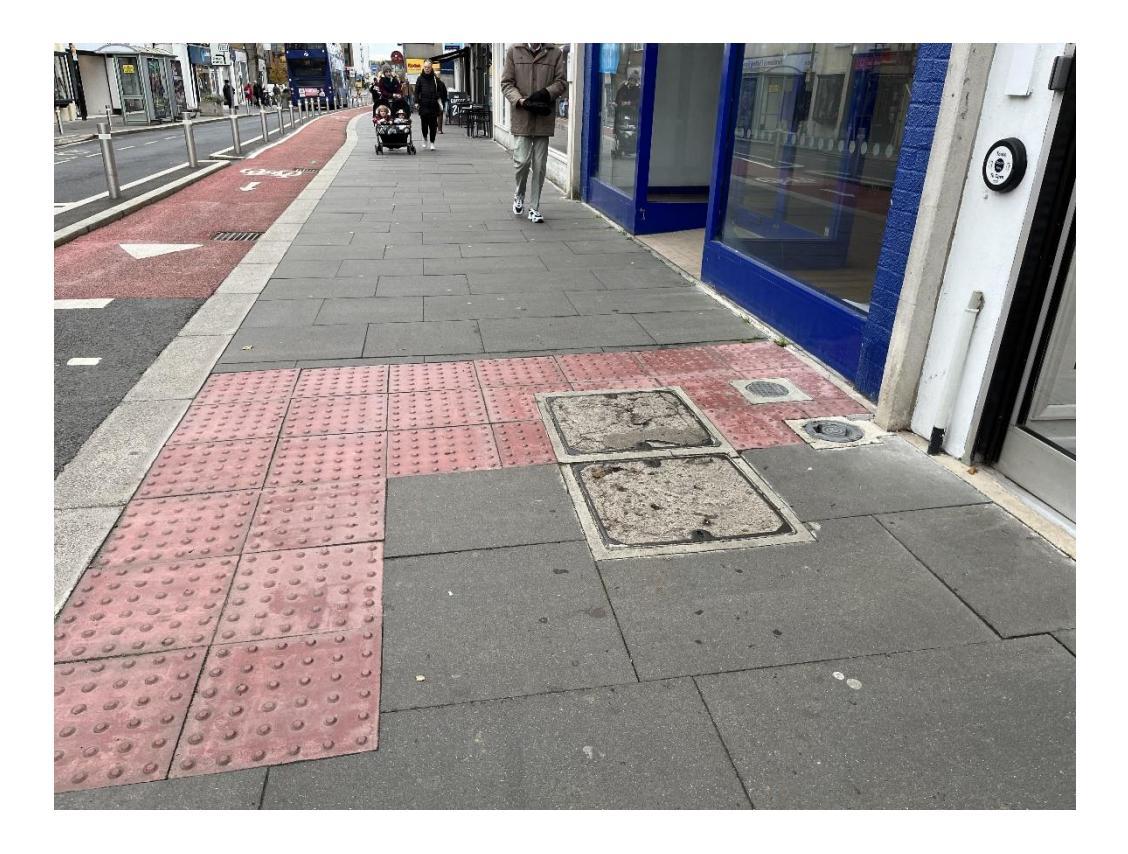
Summary: Risk of pedestrians being struck by vehicles or cyclists

The tactile arrangement on the west side of the carriageway at the Zebra Crossing has a number of utility covers within it. Blind and partially sighted users may fail to detect the crossing point and instead attempt to cross at an unsuitable location with the resultant risk of being struck by a passing vehicle or cyclist.

Provide tactile paving within the utility cover.

The Design Team consider that the chance of a blind or visually impaired pedestrian missing the tactiles which are present is low but accept that the installation of tactile paving set into a new recessed cover or stick on tactiles on the paving slab would resolve the issue.

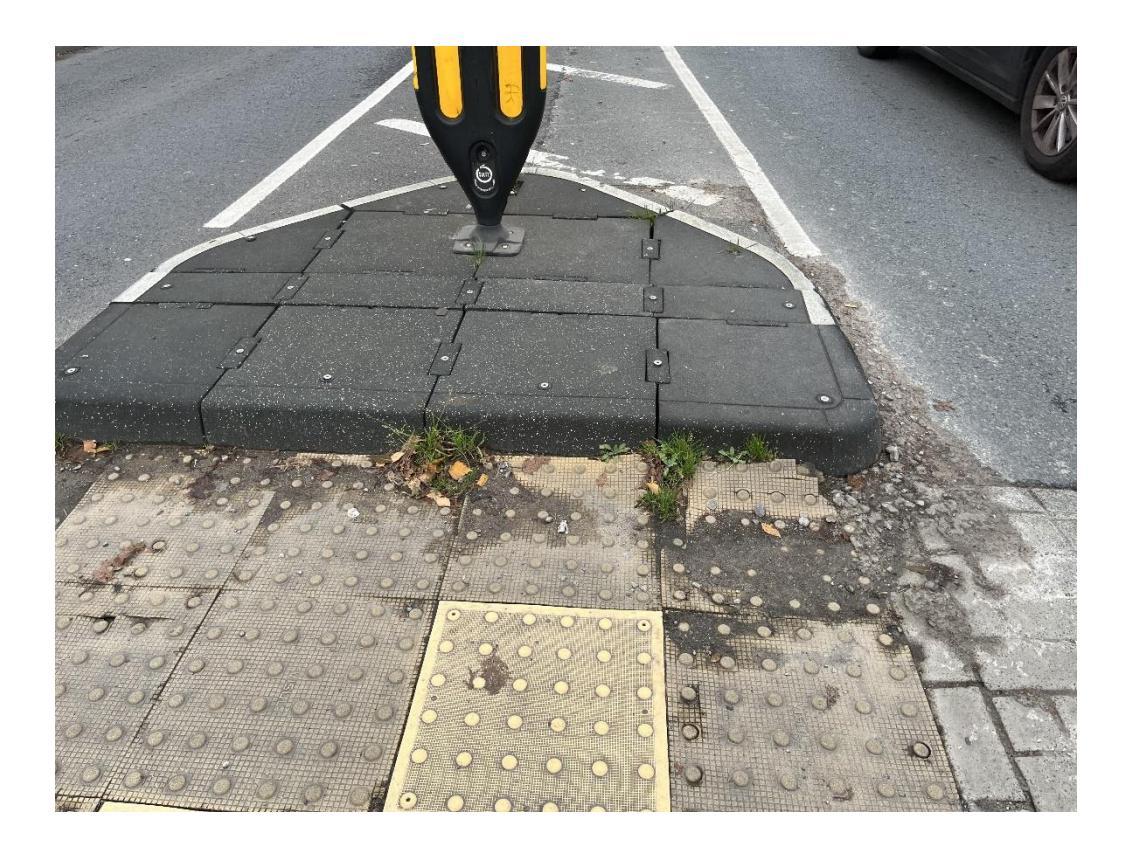
Summary: Risk of pedestrians trips

The stick-on tactile paving is broken and lifting which results in a trip hazard for pedestrians

Replace the broken tactile paving and ensure a flush finish.

Accept tactiles to be repaired.

Agree with the Design Organisation that the tactiles should be repaired.

The Overseeing Organisation to arrange for the tactiles to be repaired.

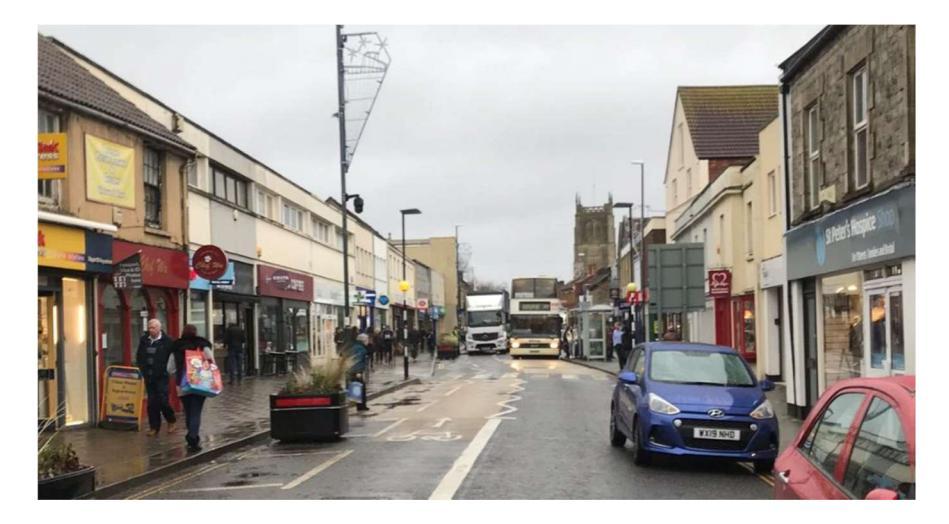
Summary: Safety concerns linked to the suitability and operation of the proposed scheme.

High Street is used by all modes of vehicles. During the site visit, large vehicles and private cars were observed parking, dropping off and unloading throughout the scheme. This included vehicles in hatched areas, parked on double yellow lines (some with blue badges visible) and unloading at the kerbside. The proposed scheme reduces the width of the carriageway and creates a defined edge on one side (the bollards between the vehicle carriageway and contraflow cycle lane). While this should discourage some of the current behavior, it could increase the level of vehicles parking on the footway in order to still allow other vehicles to continue south on High Street. This increases the potential for operational issues through the scheme and potential for conflicts resulting in injuries to pedestrians.

It is recommended that double yellow lines and loading restrictions are installed through the length of the High Street and are enforced once the scheme is operational.

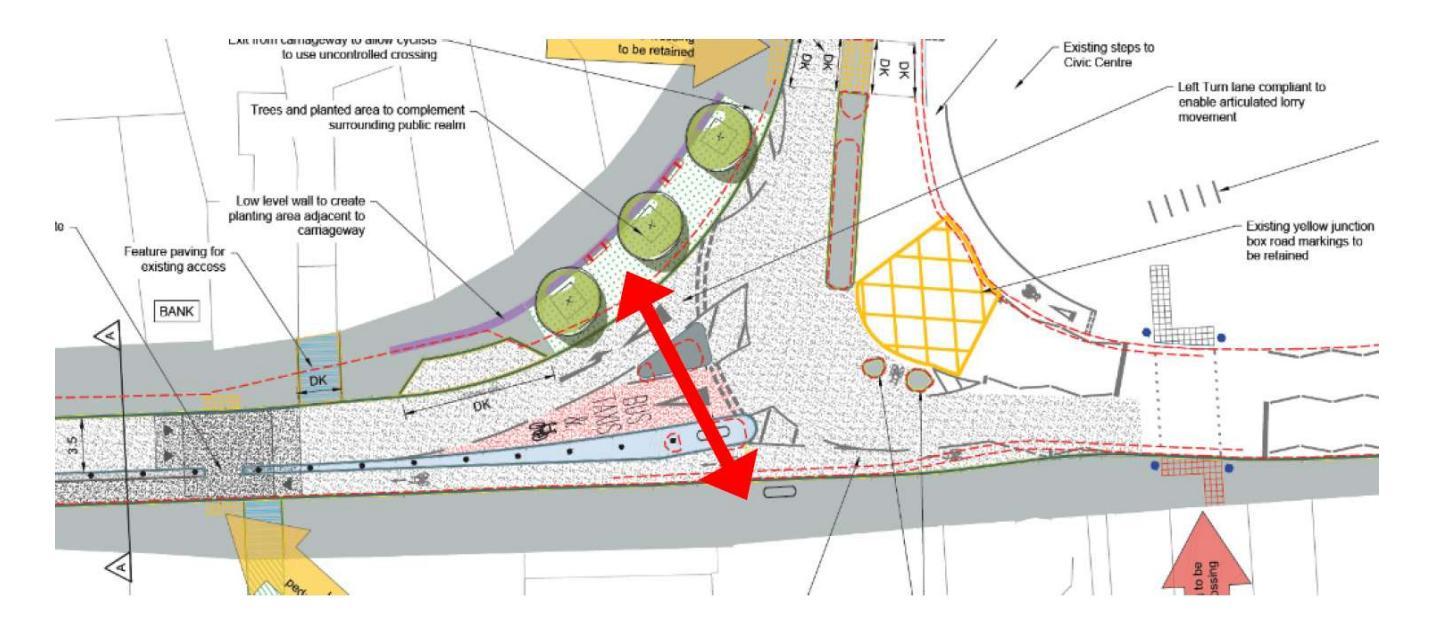
At the southern end of the High Street, at its junction with Bath Hill, an existing uncontrolled pedestrian crossing on the desire line across the mouth of the junction is being removed. During the site visit, despite the weather conditions, this crossing was well used. The alternative crossing is located 25m north, aligned with the pedestrian link connecting to Ashton Way.

It is likely that pedestrians will still cross the carriageway at this location, potentially obscured by planters and street furniture, where dropped kerbs are not provided and in conflict with vehicles and cyclists. This increases the risk of trips and falls, cyclists being unseated and conflicts with vehicles.

It is recommended that a crossing is retained on the desire line.

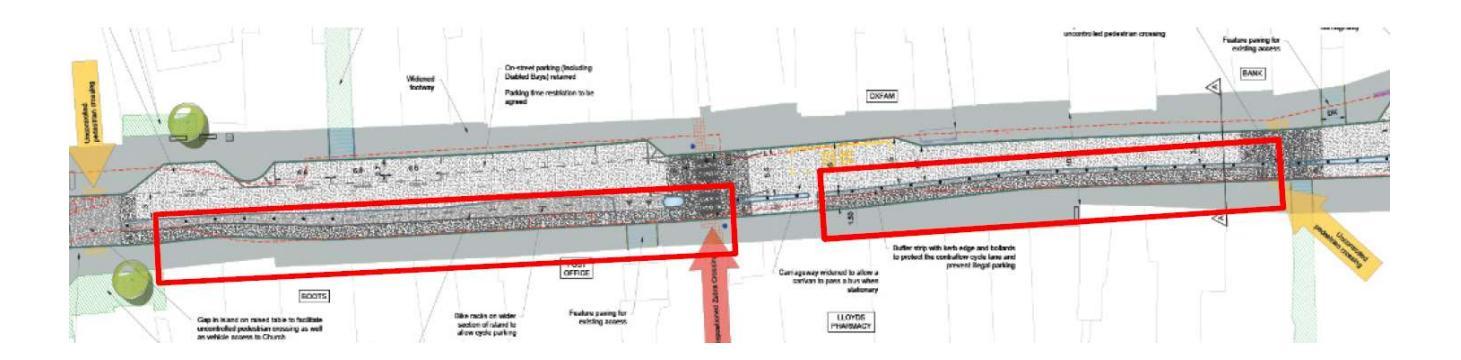
There are two extended lengths of the contraflow cycle lane that do not have any markings within them. If pedestrians are unaware of the contraflow cycle lane, they may enter the lane in conflict with cyclists. This increases the risk of cyclists becoming unseated and pedestrian injuries.

It is recommended that additional carriageway markings are provided within the contraflow cycle lane.

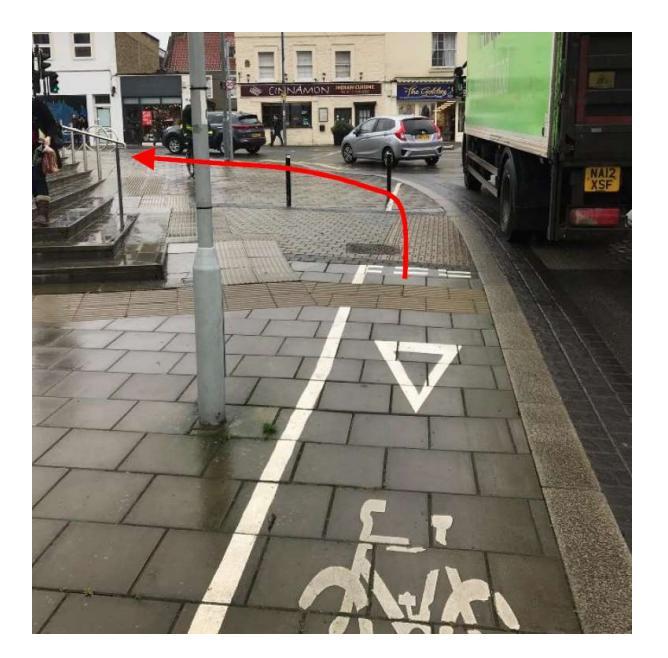
Extending the current provision increases the risk of conflicts with vehicles if cyclists re-join the carriageway prior to the Puffin crossing or as part of a right turn manoeuvre to access the High Street contraflow cycle lane. There is also an increased risk of cyclist conflicts with pedestrians at the Bath Hill uncontrolled crossing and on the Puffin crossing, which is likely to be used by cyclists as they are provided with no onward direction or requirement to dismount.

It is recommended that the cycle route is modified to better accommodate for all movements and that additional onward journey/dismount signing is provided. This signing should be in advance of the existing cycle lane and as part of the extension, in order that cyclists can position themselves/dismount accordingly.

Design Organisation Response: Adding formal cycle hop on in advance of the crossing would introduce an additional hazard in an area with existing conflicts. It is intended that the cycle lane finishes in advance of the toucan where cyclists give way to pedestrians and join the carriageway if necessary at the Toucan crossing. The cycle lane markings will be extended to the Toucan crossing. Necessary signing will be provided as part of design process.

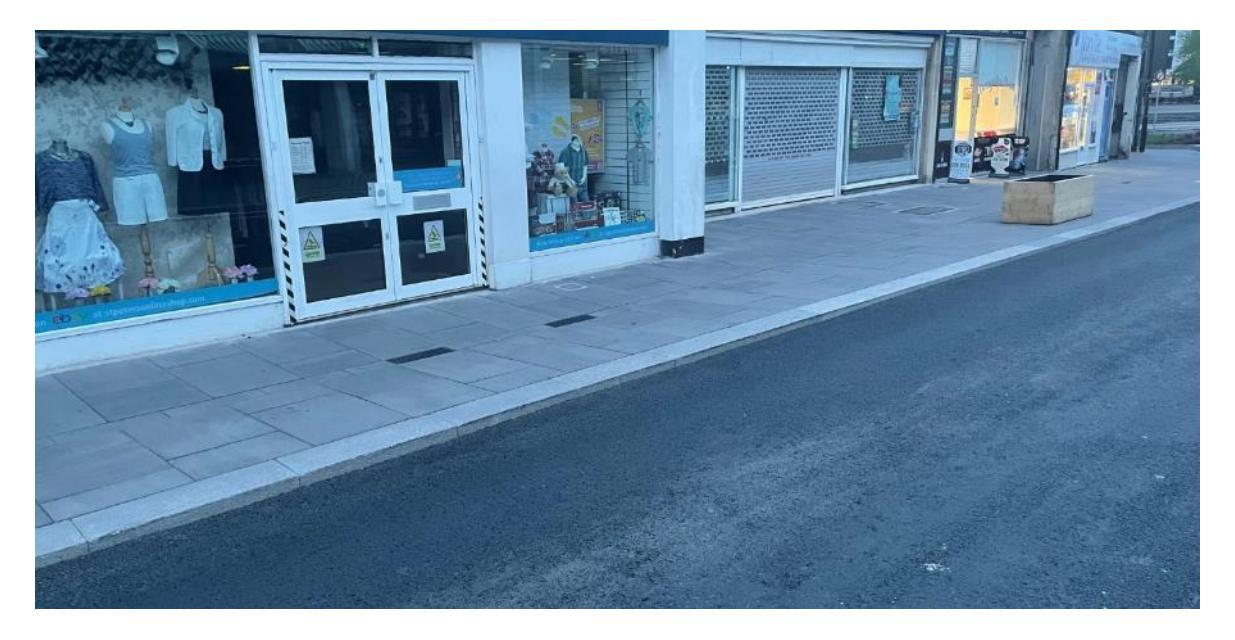
Summary: Parking on the footway increases the potential for conflicts with pedestrians

Problem: There is evidence that vehicles are parking on the footway adjacent to the High Street carriageway, particularly towards the southern end of the scheme. This increases the potential for conflicts between pedestrians and cyclists, which could result in pedestrian injuries.

It is recommended that additional physical measures are installed to discourage parking on the footway and that the existing clearway is enforced.

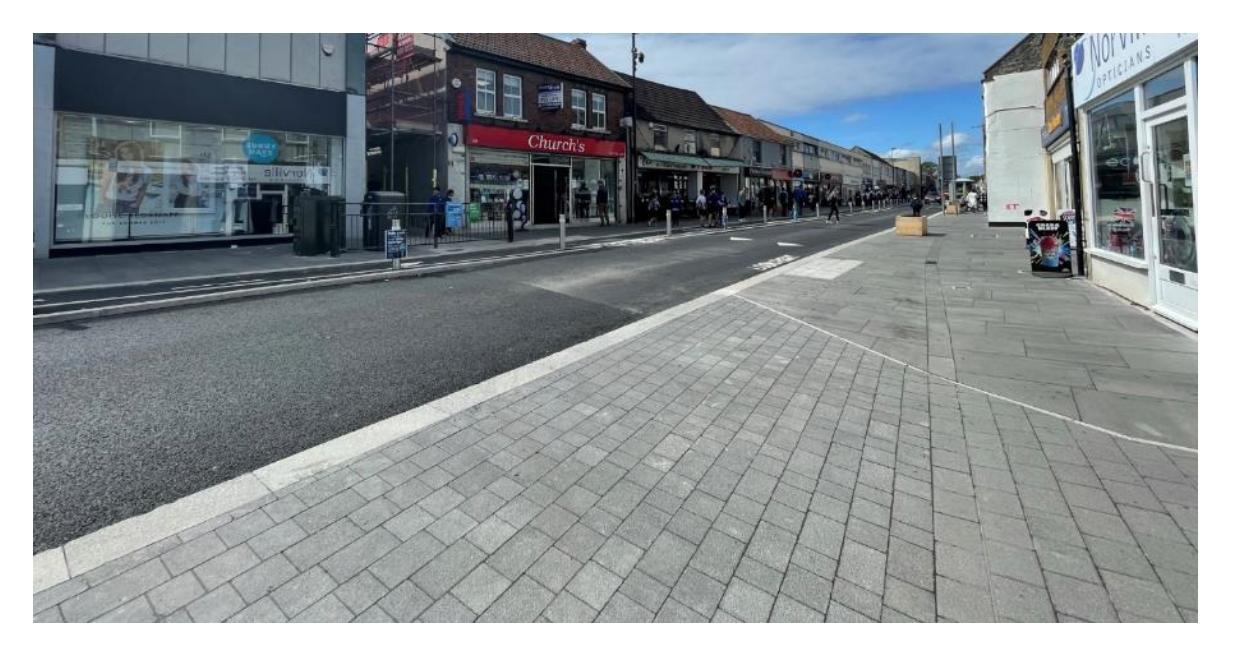
Problem: While drainage is provided in this area, it is unclear if the carriageway and footway surface water will drain adequately across the feature paved existing access adjacent to property number 69. Ponding water at this location could result in

vehicles skidding and pedestrian slips, increasing the potential for conflicts and pedestrian injuries. The problem could be exacerbated during cold conditions, when ponding water in this area may freeze.

It is recommended that the drainage provision adequately removes surface water from this area.

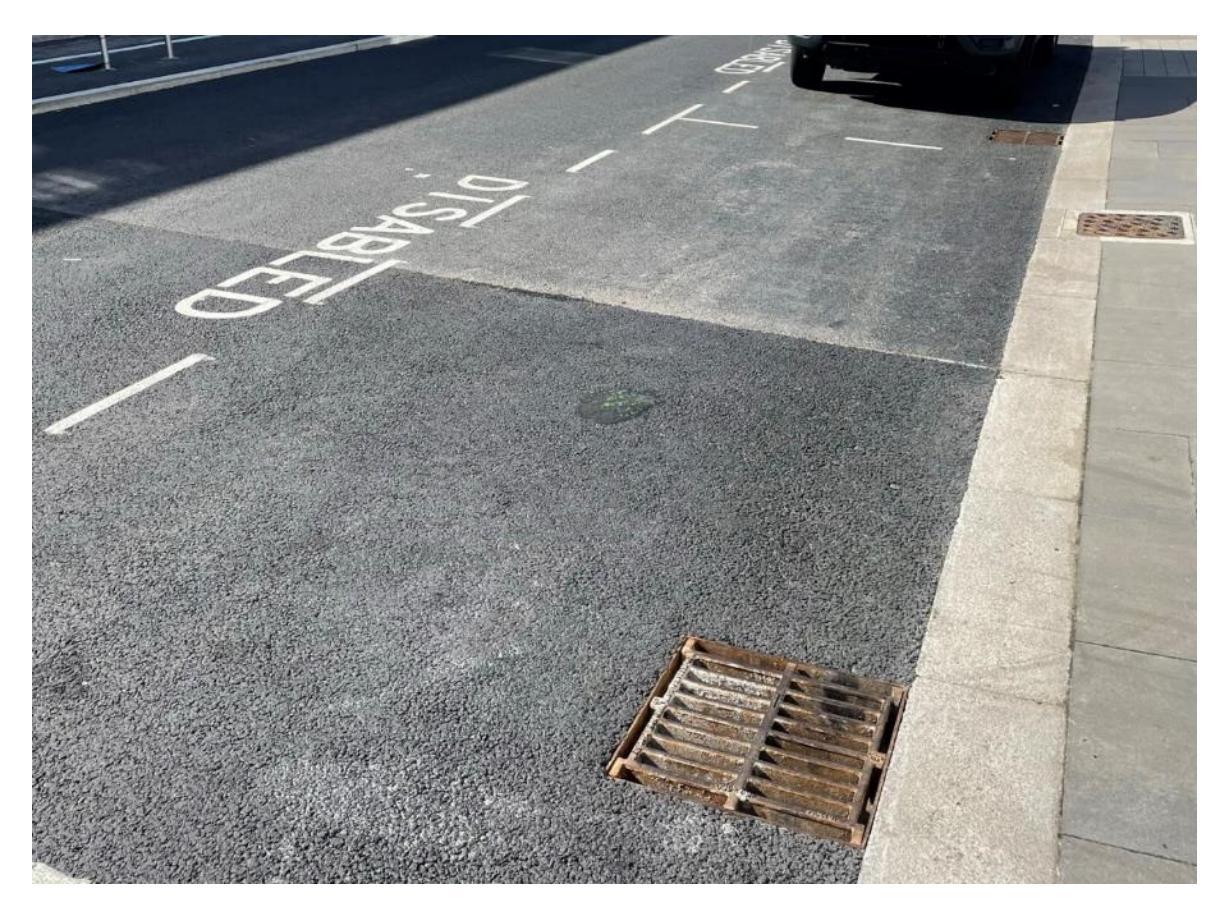
Summary: Slotted gully covers in parking bays could result in pedestrian injuries.

Problem: There are a number of slotted gully covers located within parking bays, including the disabled bays. As those leaving vehicles will likely be heading towards the footway, there is potential that heeled shoes, walking aids, pram wheels or wheelchair wheels could be trapped within the gully cover. This could results in trips, falls and abrupt stops increasing the potential for injuries.

It is recommended that pedestrian friendly gully covers are installed in place of the slotted covers.

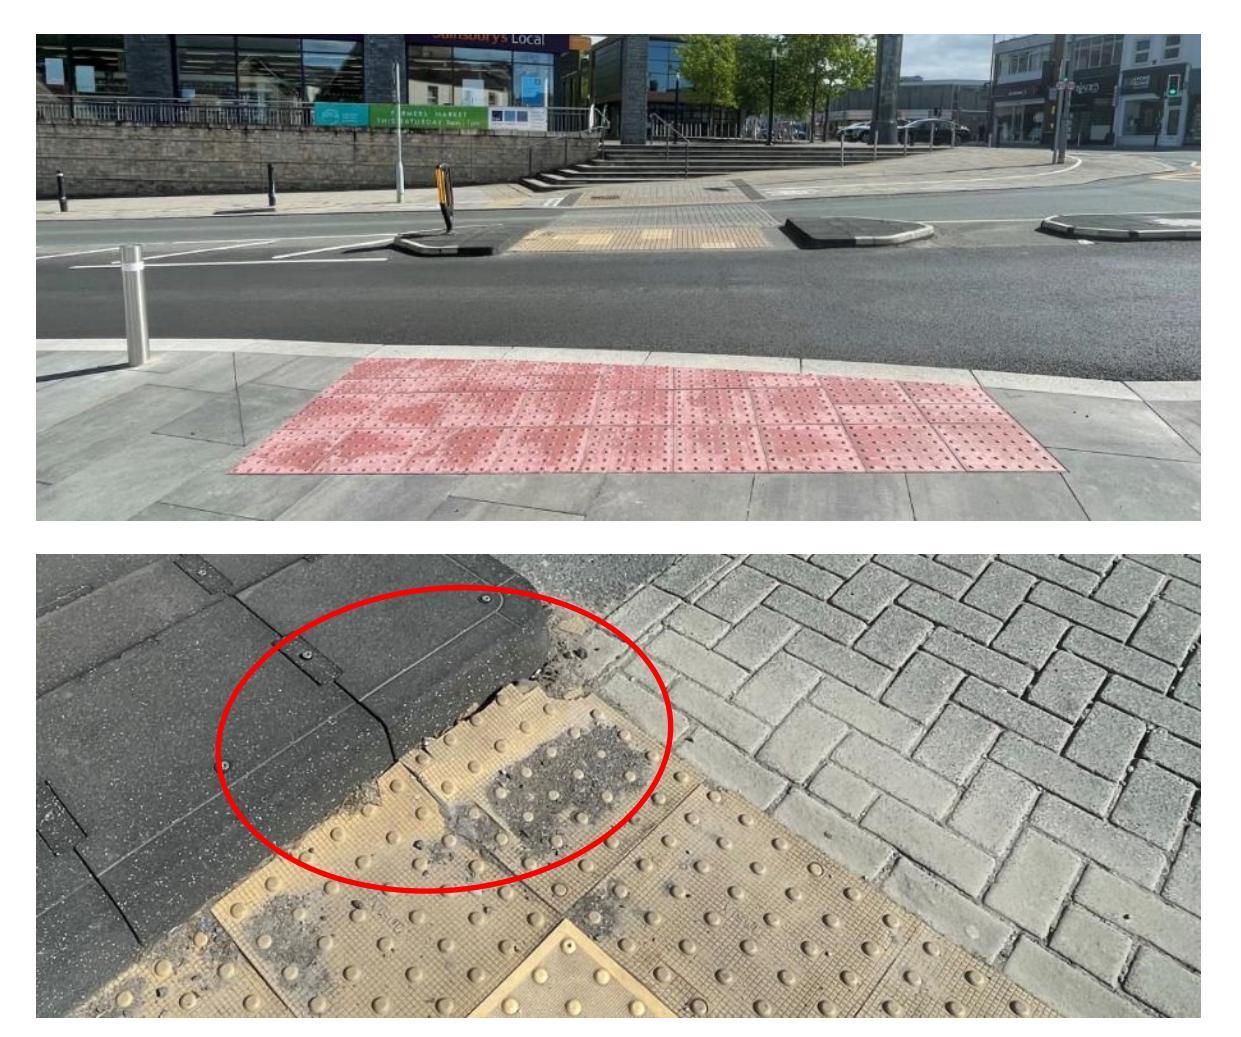
- The tactile paving on the north side of the crossing is red. Tactile paving at uncontrolled crossings should be buff.
- The tactile paving on the north side does not align with the tactile paving in the central refuge.
- The stick down tactile paving within the central refuge is lifting in places.

These issues could result in confusion for partially sighted users and increase the chance of trips and falls. Potentially into the carriageway.

It is recommended that the red tactiles are replaced with buff, that the tactiles align through the crossing and the lifting tactiles are removed and replaced.

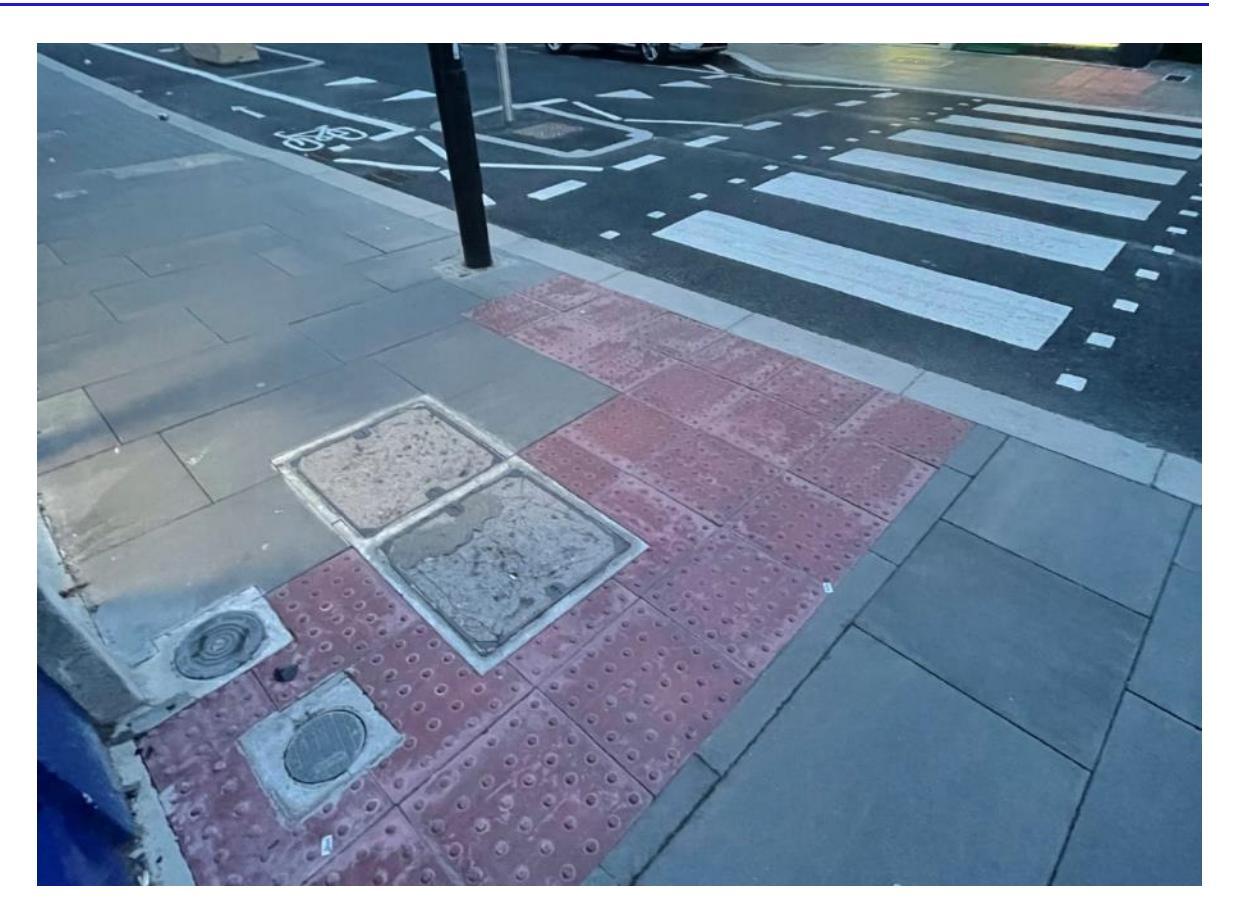
Summary: Incorrect and patchy tactile paving could result in problems for partially sighted users.

Problem: The zebra crossing provided on High Street includes incorrect tactile paving arrangements that do not guide users to the beacon. In addition, the tactile arrangement on the west side of the carriageway has a number of utility covers within it. These issues could result in partially sighted users missing the crossing point or being unclear of whether it is controlled or not. This increases the potential for pedestrian conflicts with cyclists and vehicles, which could result in injury.

It is recommended that the tactile arrangements are installed as per the DETR Guidance on Use of Tactile Paving Surfaces and that tactile paving is added to utility covers if they impact the revised layouts.

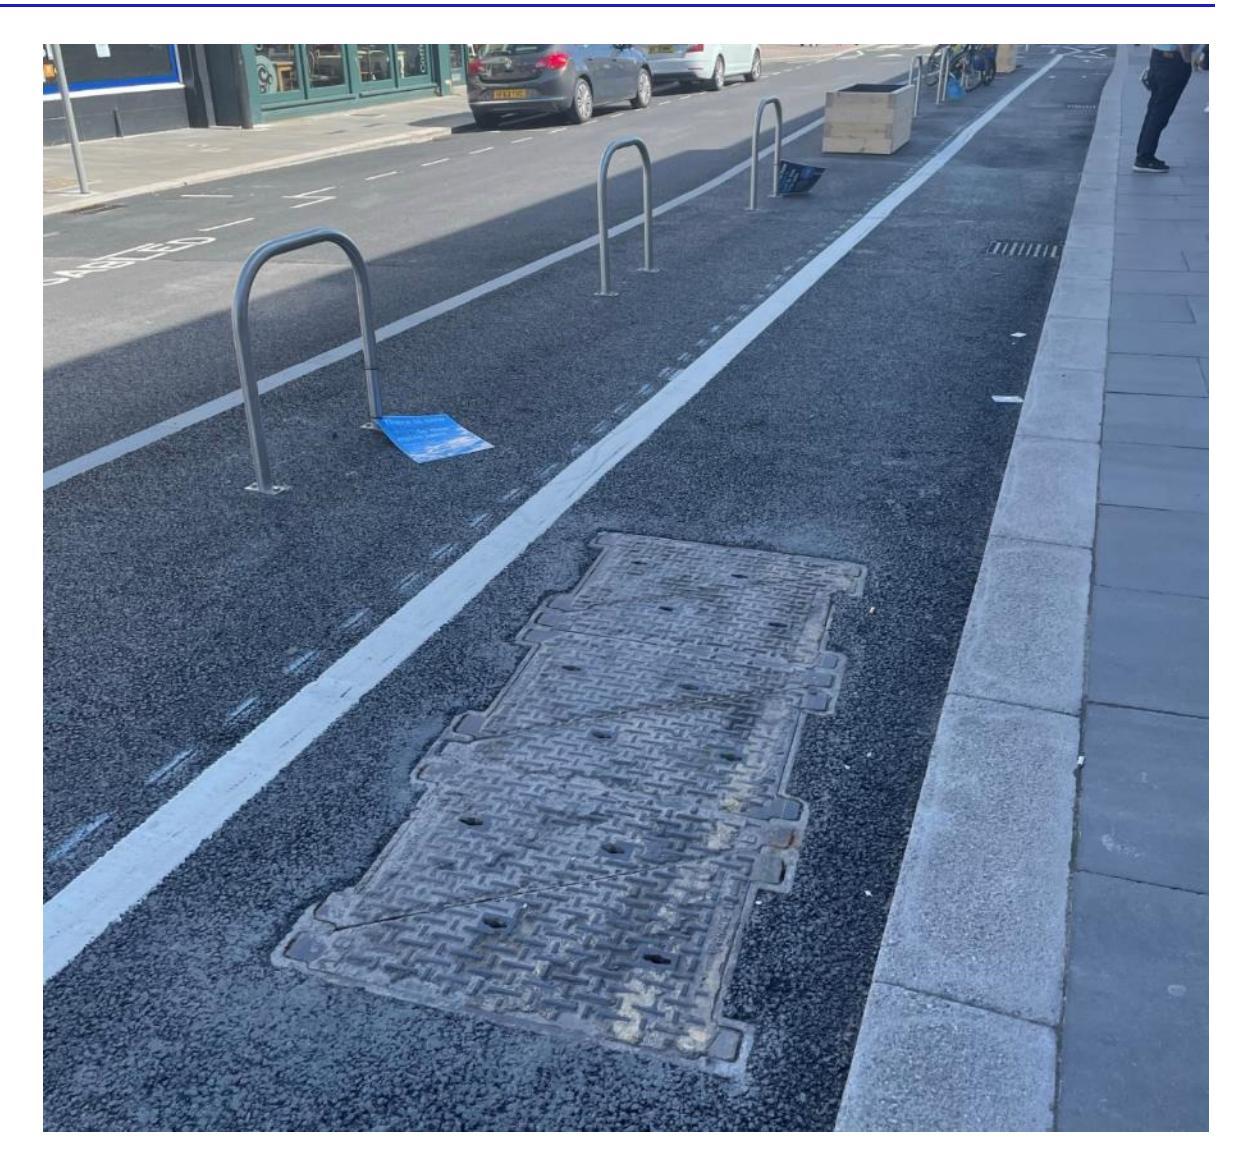
Summary: Large, smooth utility cover may become slippery when wet increasing the potential for collisions and unseated riders.

Problem: At the northern end of the scheme in front of property number 40 (The Entertainer) there is a large utility cover within the contraflow cycle lane. The cover has a metal finish and is relatively smooth. When wet, it is likely this cover will be slippery and could impact braking cyclists, resulting in riders being unseated, leading to injuries.

It is recommended that the cover is treated with an antiskid material.

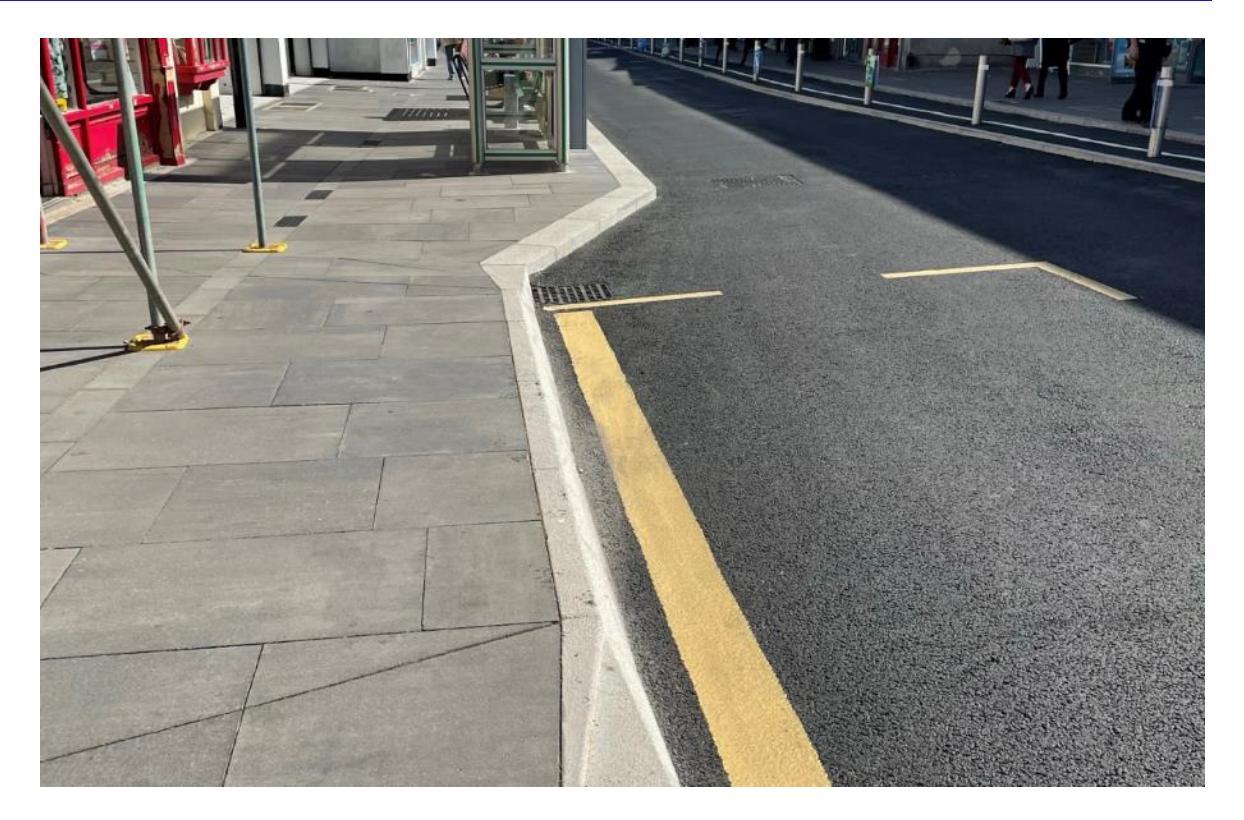
Summary: Lack of corduroy paving could result in partially sighted pedestrians falling into the carriageway.

Problem: Corduroy paving has not been installed at the kerb edge of the bus stop on High Street. This could result in partially sighted pedestrians being unaware of the raised kerb, leading to trips and falls, potentially into the carriageway.

It is recommended that corduroy paving is installed as per the DETR Guidance on Use of Tactile Paving Surfaces.

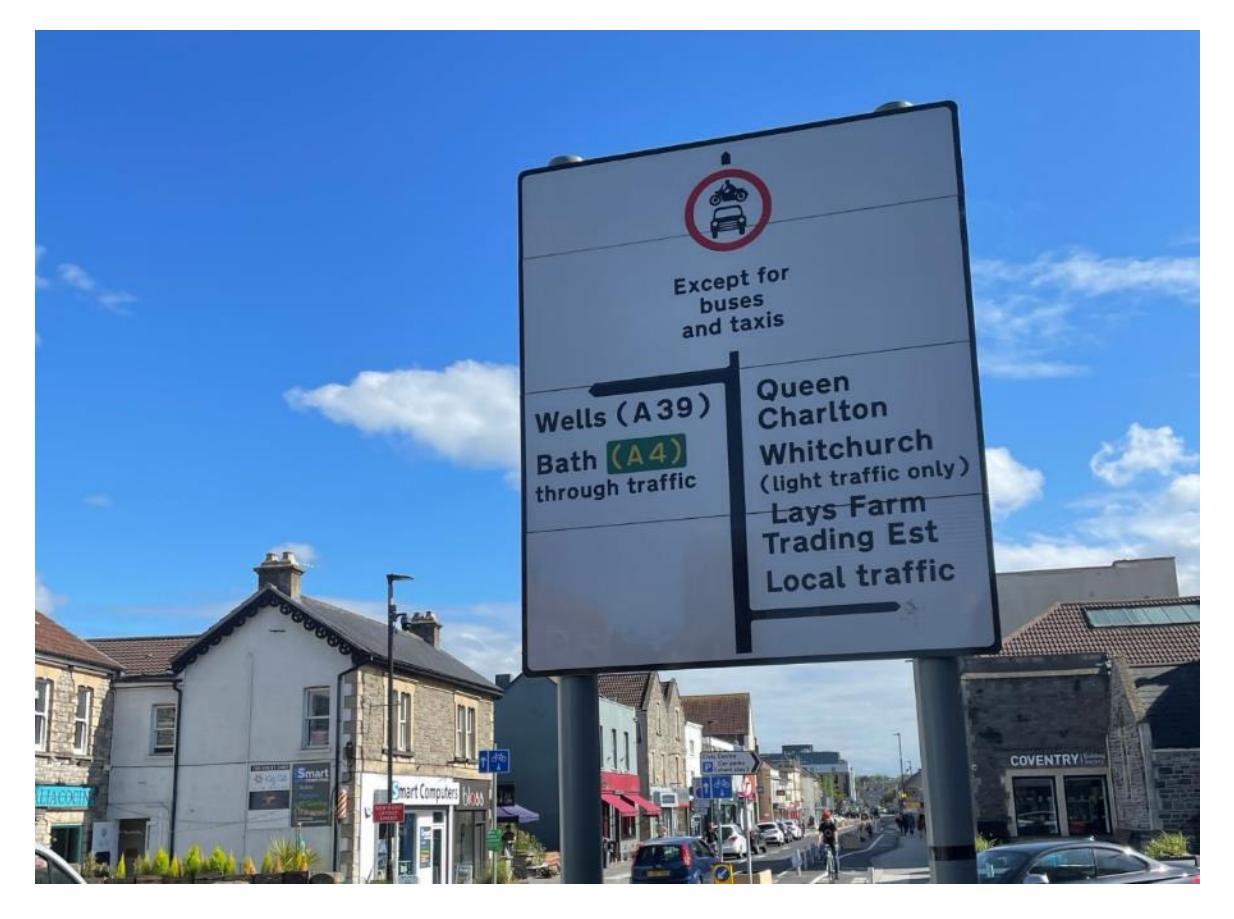
Summary: Confusing map type direction sign could result in rear shunt collisions.

Problem: On the southbound approach to High Street a map type direction sign is provided. The layout of this sign could result in confusion as drivers could interpret that the High Street (ahead) is for buses and taxis only. Confusion and hesitation at this location could increase the potential for rear shunt collisions.

It is recommended that the sign face is revised.
