# Stage 2 Road Safety Audit

## Exceptions Report

A36 Rossiter Road, Bath, Widcombe  
Parade One Way Eastbound

Bath and North East Somerset  
Council

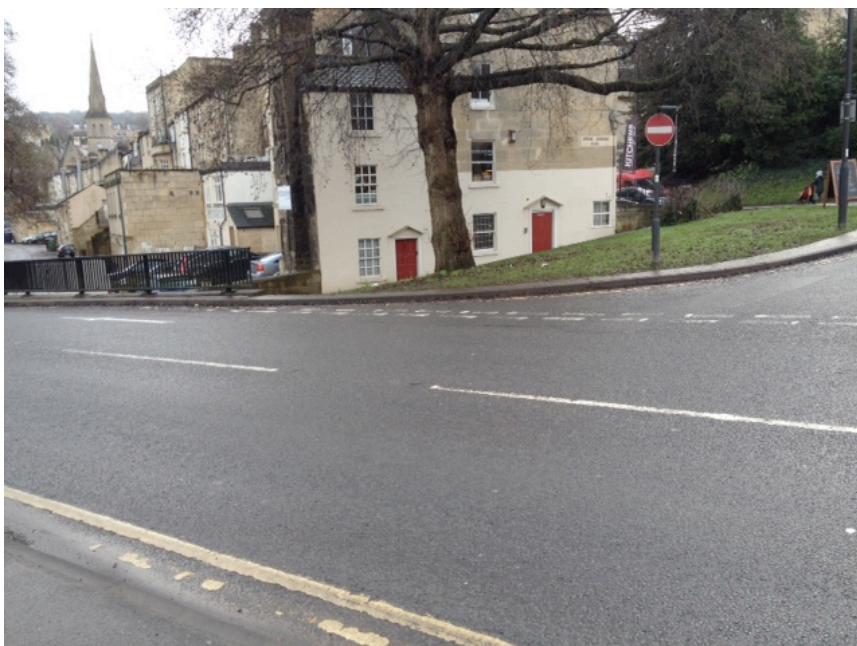
**Summary:** Lack of drainage

The carriageway falls significantly from Widcombe Parade to Rossiter Road. No drainage has been provided on the south side of the splitter island opposite Widcombe Parade. This may result in surface water collecting in the vicinity of the pedestrian crossing point, increasing the risk of slips and falls.

**Recommendation**

Ensure that adequate drainage is provided.

**Response**

**It is confirmed that adequate drainage has been provided.**

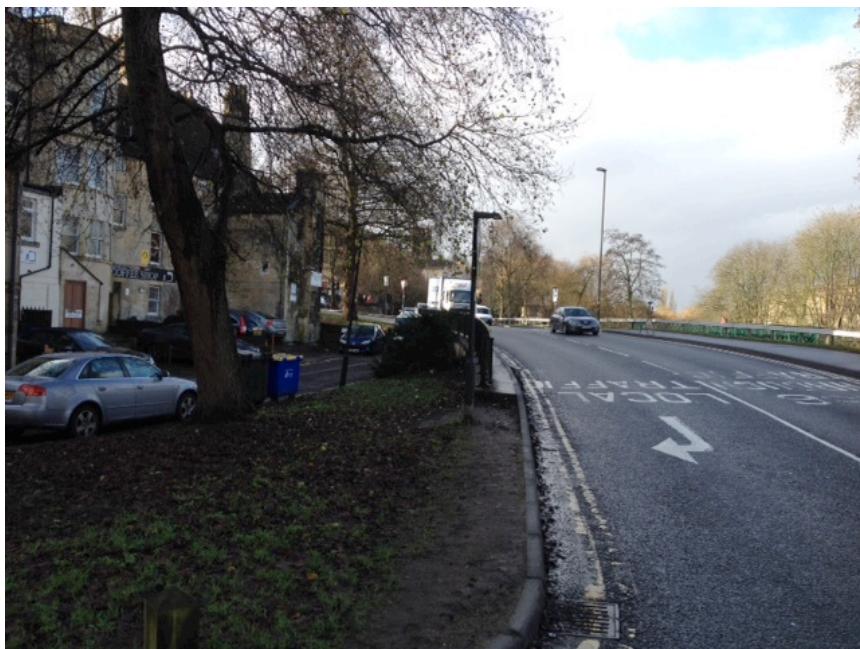
Summary: Forward visibility to westbound signal heads

Forward visibility to the westbound signals on Rossiter Road is likely to be restricted by the nearside retaining wall and existing tree immediately prior to the signals, increasing the risk of late braking and rear shunts.

There is a possible 'see through' effect to the adjacent puffin crossing to the west of the signals resulting in driver confusion.

#### Recommendation

Ensure that appropriate forward visibility to the nearside signal heads is achieved.

Position the signal heads to avoid see through and provide louvers as necessary.

#### Response

**The height of the nearside retaining wall is such that it will not restrict visibility to the signal head on the westbound Rossiter Road approach. Similarly, all trees within the visibility envelope will be trimmed.**

**The location of the signal heads for the puffin crossing on Claverton Street will be reviewed to limit the "see through" effect. Louvers will be provided.**

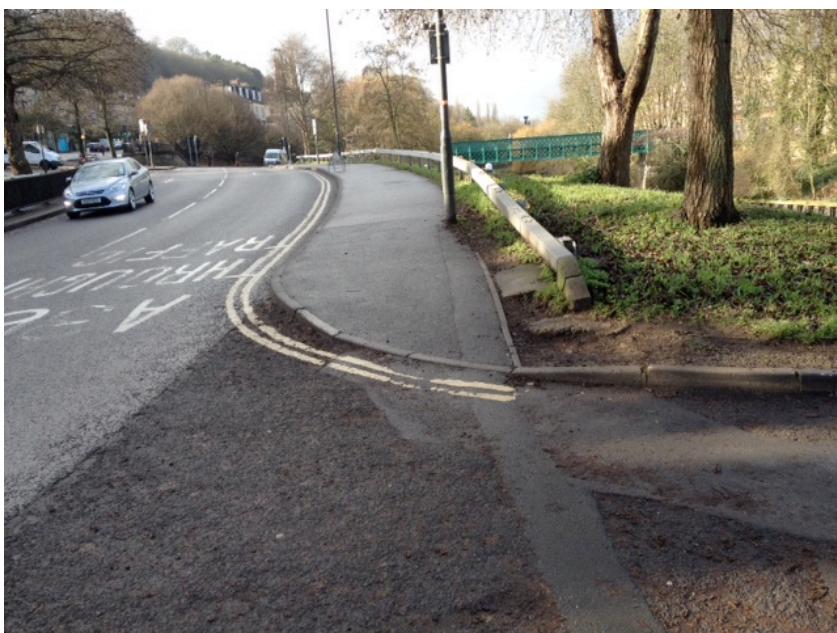
##### **Summary: Visibility from the canal access**

Visibility from the canal access may be restricted by vehicles waiting in the proposed drop of layby located approximately 8m west of the access. This could increase the risk of failure to giveaway collisions and conflicts with cyclists joining the carriageway from the shared footway/cycleway.

##### **Recommendation**

Provide appropriate forward visibility to and from the access.

##### **Response**

**This vehicle access is limited to occasional use by the “Canal and River Trust” traffic. Vehicles exiting onto Rossiter Road will be limited to the left turn only.**

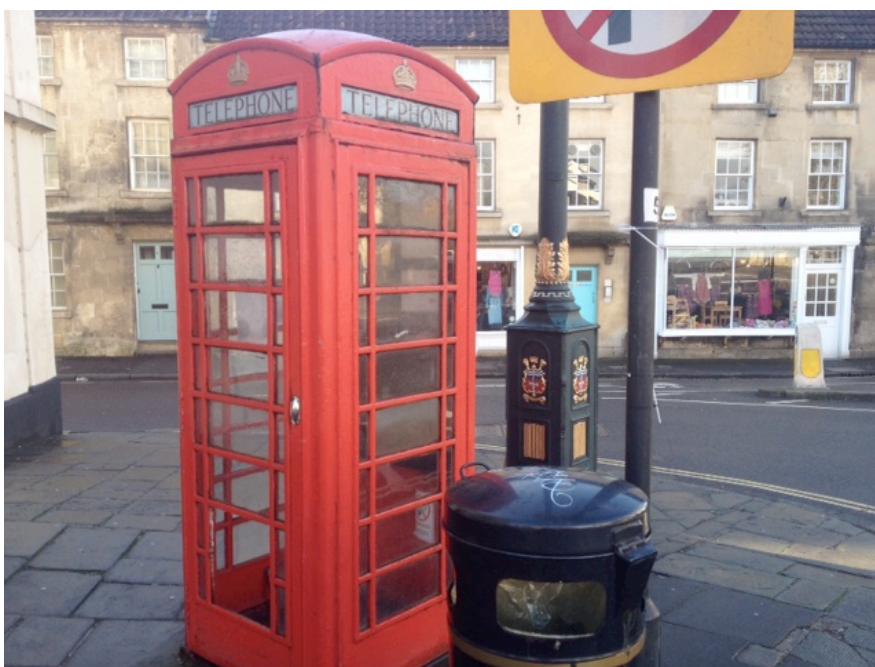
**Summary:** Restricted visibility to the right

Visibility to the right from the Prior Park Road approach to the mini roundabout is likely to be restricted by an existing telephone box and other street furniture resulting in failure to give way collisions.

#### **Recommendation**

Ensure that appropriate visibility to the right is provided.

#### **Response**

**Visibility to the appropriate give way line is not restricted by street furniture.**

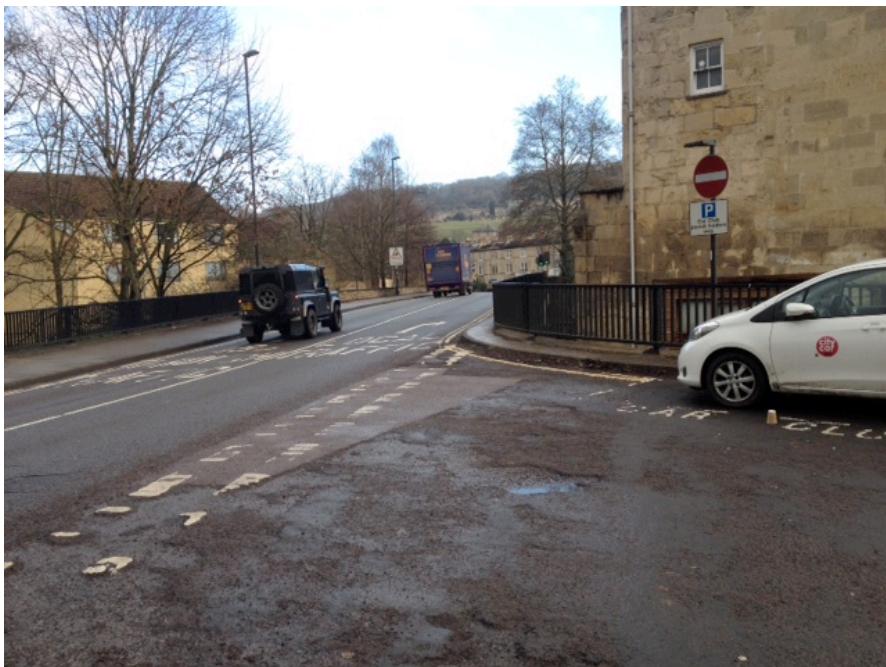
**Summary:** Restricted visibility to the right

Visibility for vehicles exiting the car park off Rossiter Road is restricted to the right by the existing bridge parapet. Now that Rossiter Road is two way, exiting the car park will be more difficult increasing the risk of failure to giveaway collisions.

#### **Recommendation**

Ensure that sufficient visibility from the car park exit is provided.

#### **Response**

The layout of the service area and car park has been reviewed and it will be amended so that the existing entrance and exit onto Rossiter Road are reversed. There is sufficient visibility to the right for traffic exiting this area from the western junction with Rossiter Road. The restricted visibility to the left will be mitigated by imposing a left turn only restriction.
