## C8 - Site Condition Report

Address: Ashmead Road, Ashmead Industrial Estate, Keynsham, Bristol.

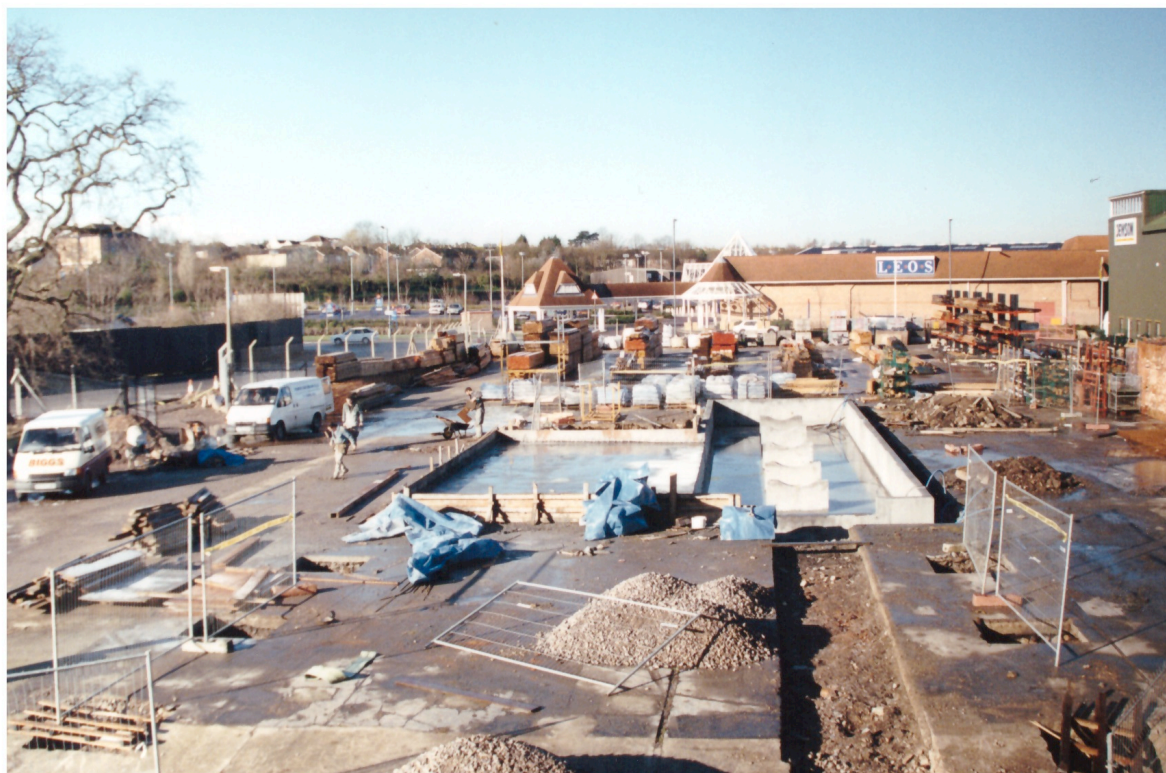
The following image shows installation of the existing plant, in 1995:

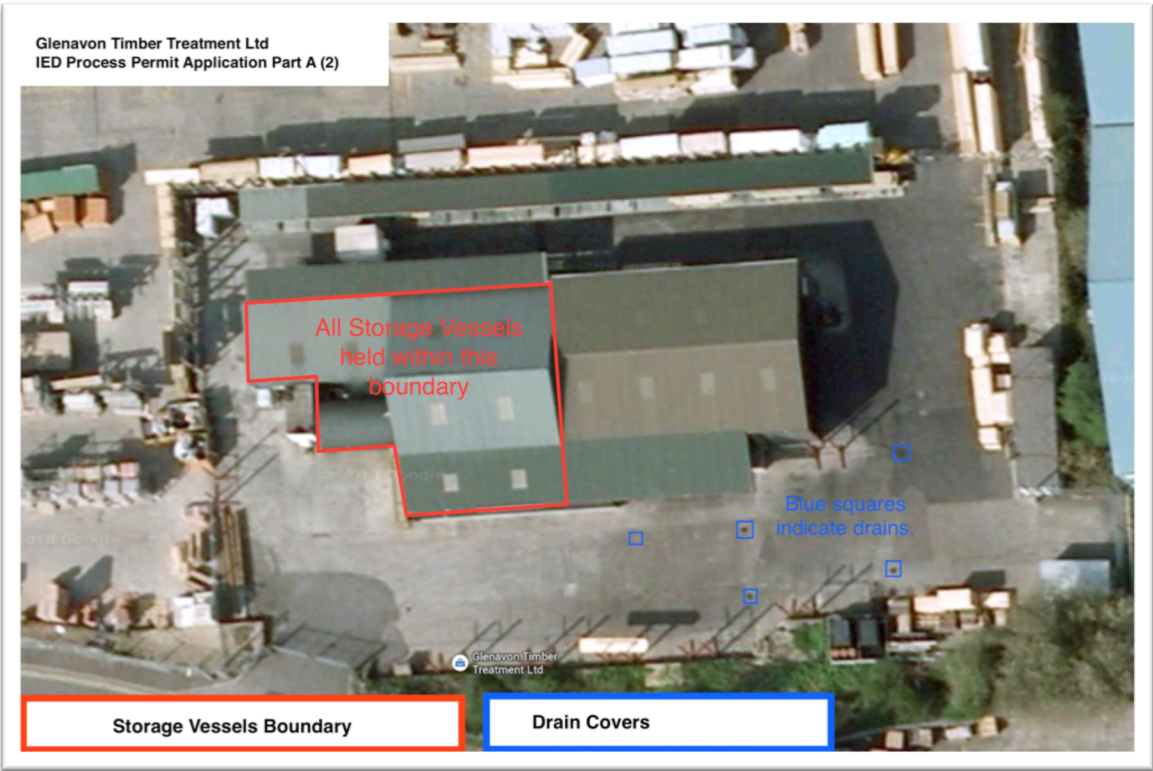
Site Storage / Drainage Plan:

The entire site is concreted, so no 'bare earth' areas exist. All water drains are well clear of the bunded area and as such will only be used to disperse run-off rainwater as they were designed to do.
