Chew Magna Property Level Protection Scheme Evaluation

Final Report

August 2013

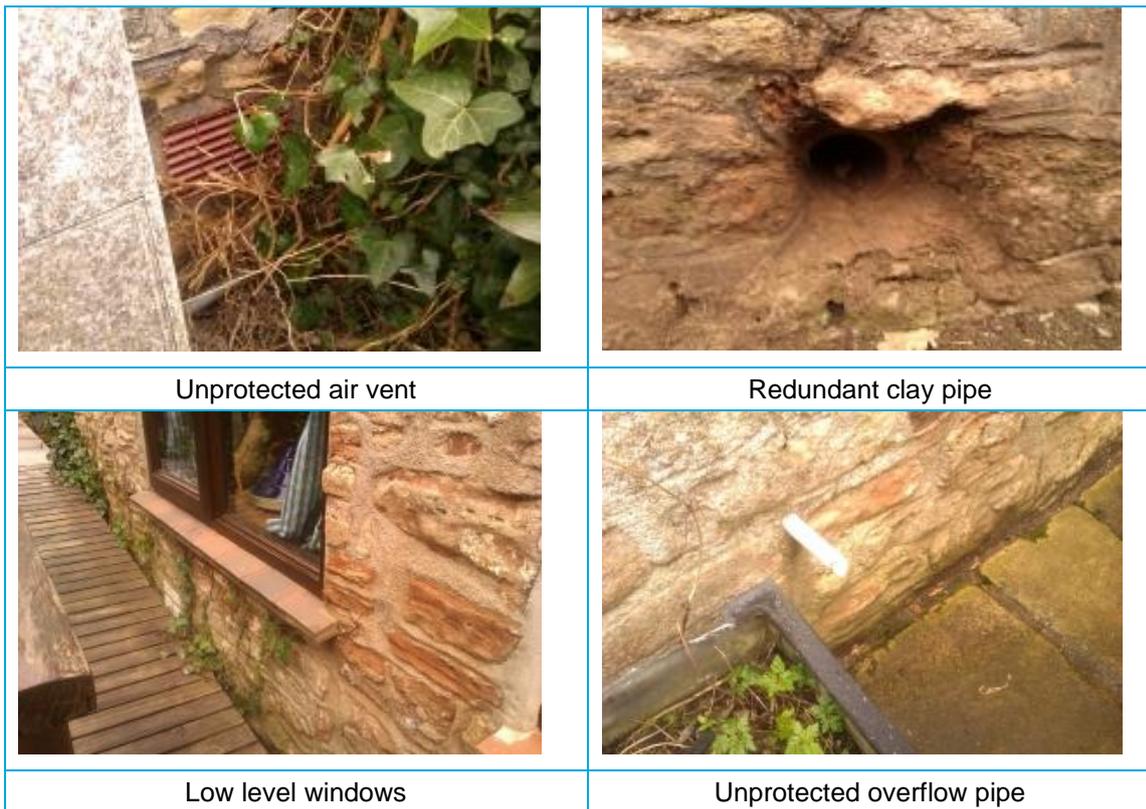
Figure 4-2 Examples of missed ingress routes

This investigation did not extend to resurveying and auditing of properties, however a limited number were checked as part of the current investigation. From this small sample, evidence was found of potential ingress routes that had been missed at a number of properties selected for review. This included missed air vents, unprotected drainage pipes and unprotected windows with the same sill levels as adjacent protected windows. Residents subsequently reported ingress of water adjacent to and possibly through these drainage routes.

A cross-checking system was in place to record and address any discrepancies between the survey and the installation phase. However despite this, it appears from this small (and therefore unrepresentative) sample of sites in this early Defra Pilot Scheme that not all potential ingress routes or flood sources had been addressed. The experience and competence of property flood risk surveying companies has since increased and the industry has matured significantly; this was one of the objectives of the original Defra Pilot Scheme.

Given the ingress routes missed by the property flood risk surveyors (identified in section 4.3.3), the responsibility of the installer should be reinforced. Product installers should not simply follow a Bill of Quantities provided by the surveyor, but should scrutinise those identified ingress routes during the install phase and question the surveyor for discrepancies where necessary. The respective roles should remain independent, but a greater degree of data exchange and review of recommended products is strongly encouraged. It is noted that such cooperation between surveyor and installer now exists on many PLP schemes.

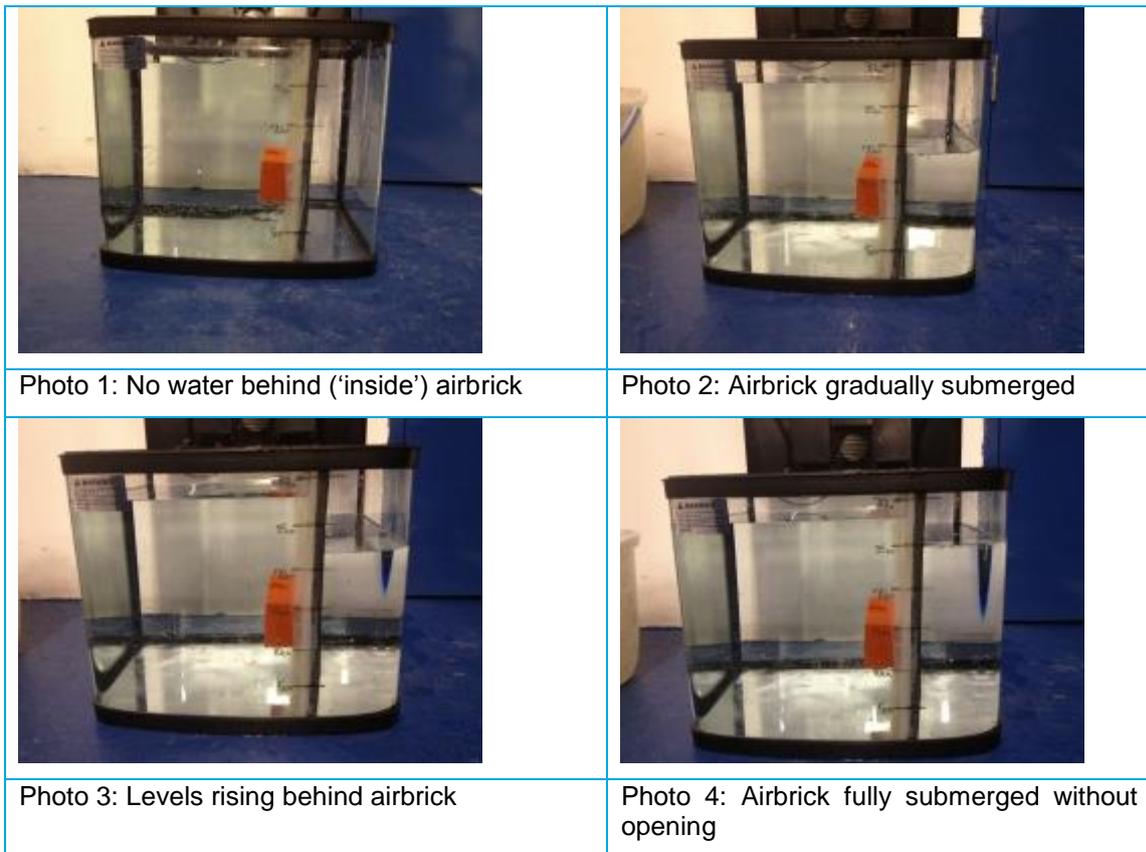
Figure 4-4 Photos of self-closing airbrick operation

Finally, in some instances the barriers operated effectively, but were bypassed at other ingress routes. There were concerns from some residents that the self-closing airbricks had suddenly 'failed', thereby allowing water to enter sub-flood cavities. The hypothesis provided for this was that a low level of flooding had entered the cavity via cracks and in the walls and sub-floor, which was sufficient to force the flap-valves to open and allow ingress from outside the property. With outside floodwater levels exceeding those inside the property however, the hydraulic pressure would not allow this to occur, and the following photographs illustrate a tank test that demonstrates this point.

Note: As water level on the 'inside' of the airbrick was increased the flap valve remained closed, thereby retaining the water on the 'outside'. This dispels the theory that internal flooding caused the airbrick to open.
