Potential Gypsy & Traveller Site
Old Colliery Buildings, Stanton Wick, Somerset

Preliminary Land Quality Risk Assessment

SLR Ref: 402-00934-00021-002

Bath & North East
Somerset Council

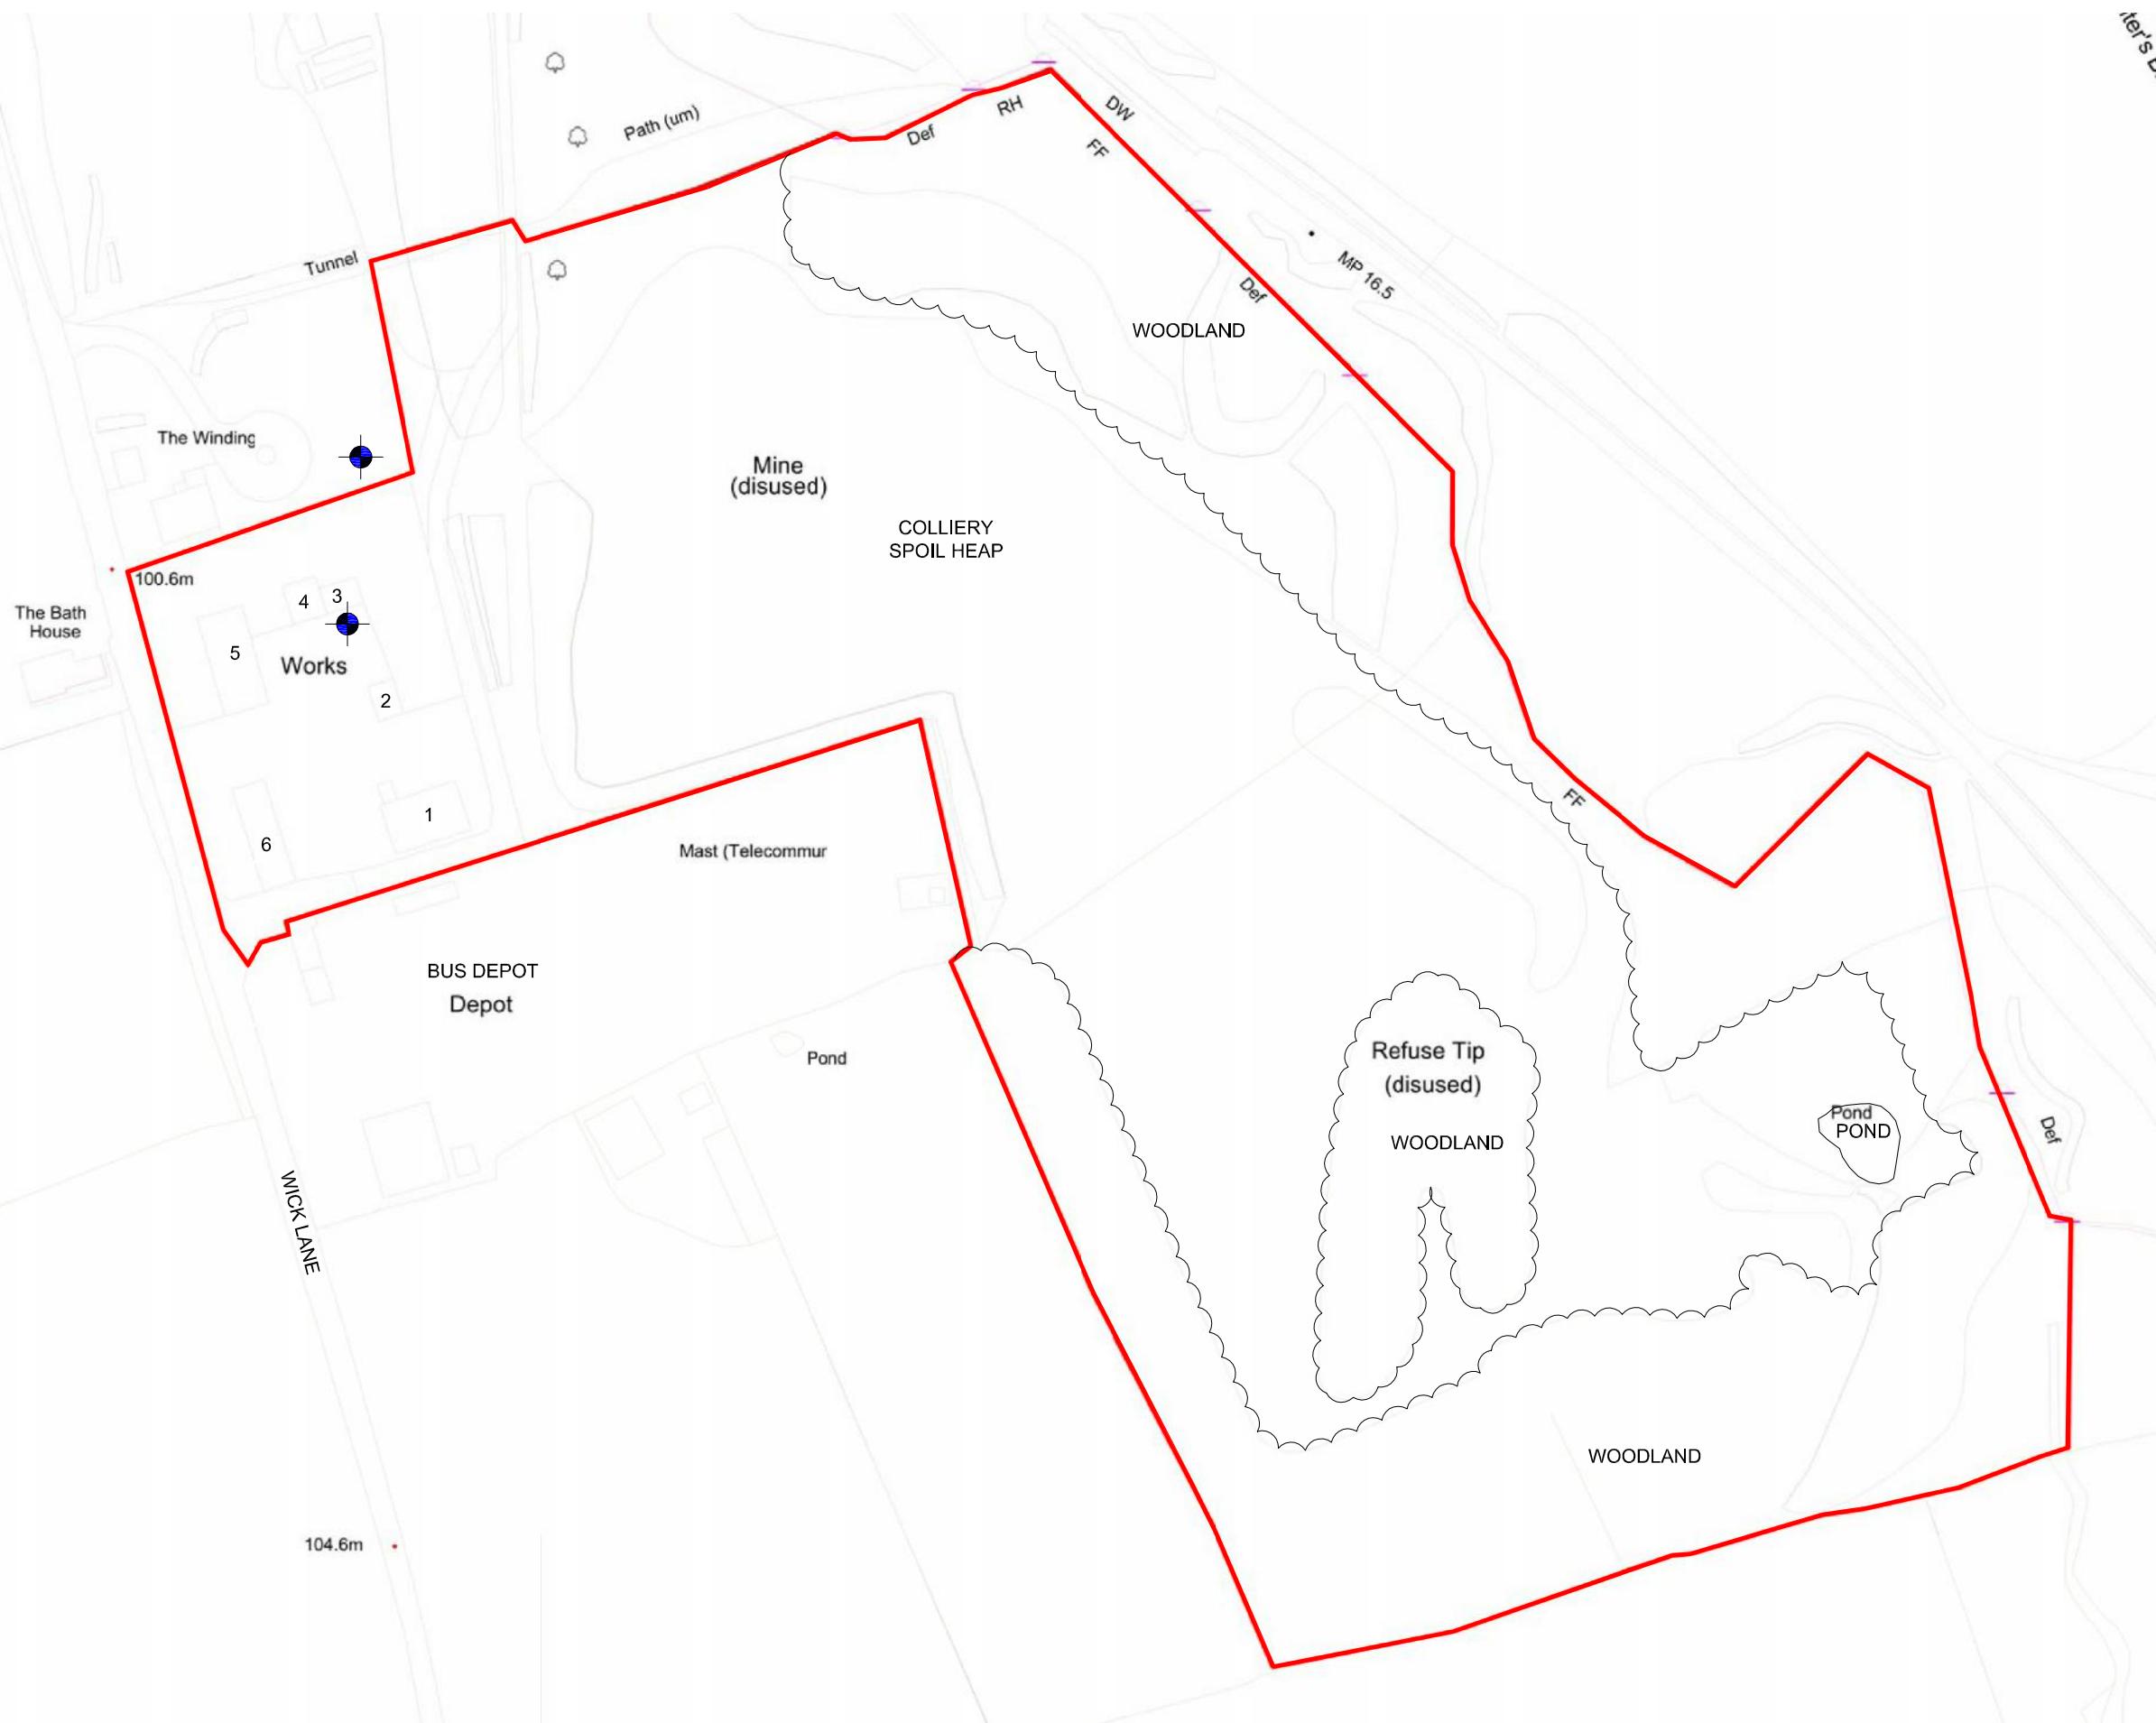
LEGEND

- SITE BOUNDARY
- INFERRED LOCATION OF SHAFT

- Drawing 1 Site Location Plan
Drawing 2 Current and Historic Layout
